No.76 IACS Guidelines for Surveys, Assessment and Repair of Hull Structure – Bulk Carriers

(1994)
(Rev.1
July 2001)
(Rev.2
June 2004)
(Corr.1
Sept 2007)

BULK CARRIERS

Guidelines for Surveys, Assessment and Repair of Hull
Structure

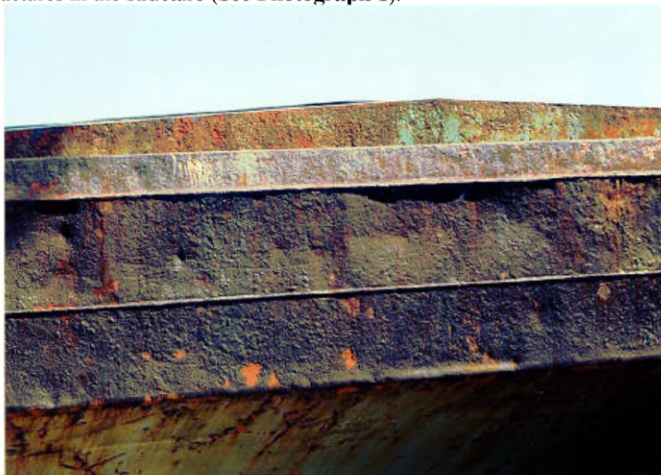
- 3.1.1** The level of wastage of under-deck stiffeners/structure in cross deck may have to be established by means of thickness measurements. The combined effect of the marine environment and the high humidity atmosphere within cargo hold s will give rise to a high corrosion rate.
- 3.1.2** Severe corrosion of the hatch coaming plating inside cargo hold and topside tank plating vertical strake may occur due to difficult access for the maintenance of the protective coating. This may lead to fractures in the structure (See **Photograph 1**).

Photograph 1 **Heavy corrosion of hatch coaming and topside tank plating vertical strake**

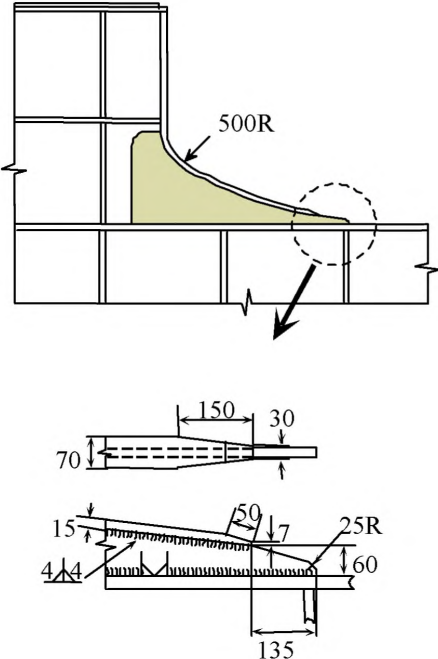
<p>500R</p> <p>150 30 70 15 50 7 25R 60 135 4 4</p>
Notes on possible cause of damage 1. This damage is caused by stress concentrations attributed to the design of the bracket.		Notes on repairs 1. The design of the bracket can be altered as shown above, however, it is to be ensured that an additional under deck stiffener is provided at the toe of the termination bracket, where the toe is clear of the normal stiffening member. 2. The fracture in deck plating to be veed-out and rewelded or deck plating cropped and part renewed as appropriate, using low hydrogen electrodes for welding.

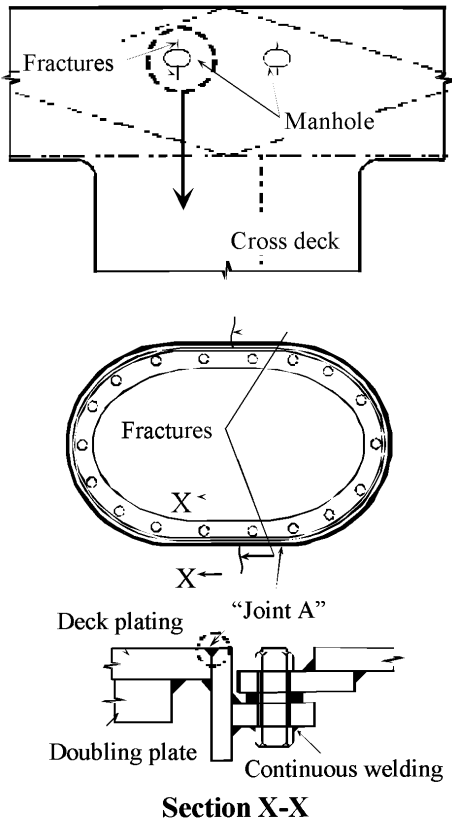
BULK CARRIERS		Guidelines for Surveys, Assessment and Repair of Hull Structure
Part 1	Cargo hold region	Example No.
Area 1	Deck structure	4
Detail of damage		Fractures in deck plating initiated from weld of access manhole
Sketch of damage

<p>Fractures</p> <p>Manhole</p> <p>Cross deck</p> <p>Fractures</p> <p>X-X</p> <p>Deck plating</p> <p>Doubling plate</p> <p>Continuous welding</p> <p>Joint A</p> <p>Section X-X</p>		Sketch of repair

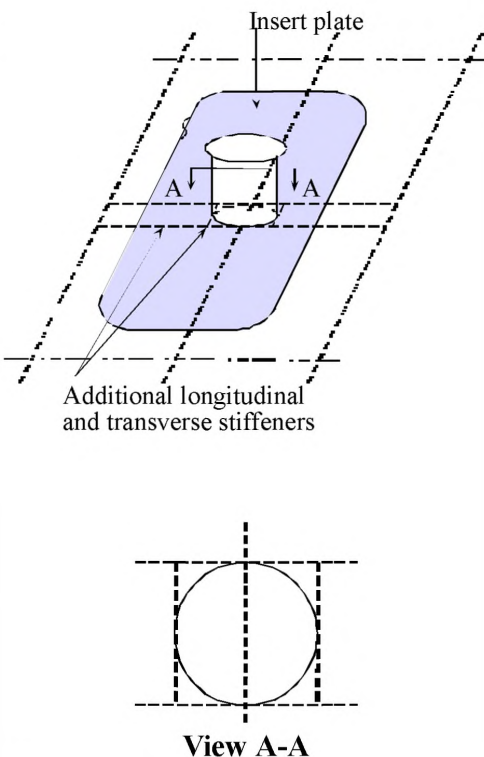
BULK CARRIERS		Guidelines for Surveys, Assessment and Repair of Hull Structure	
Part 1	Cargo hold region		Example No.
Area 1	Deck structure		5
Detail of damage		Deformed and fractured deck plating around tug bitt	
Sketch of damage		Sketch of repair

Notes on possible cause of damage		Notes on repairs	
<ol style="list-style-type: none"> Insufficient strength 		<ol style="list-style-type: none"> Fractured/deformed deck plating should be cropped and part renewed. Reinforcement by stiffeners should be considered.

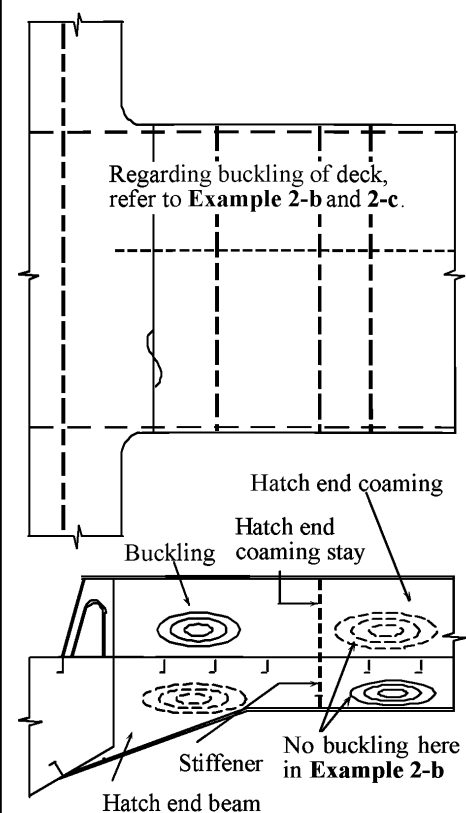
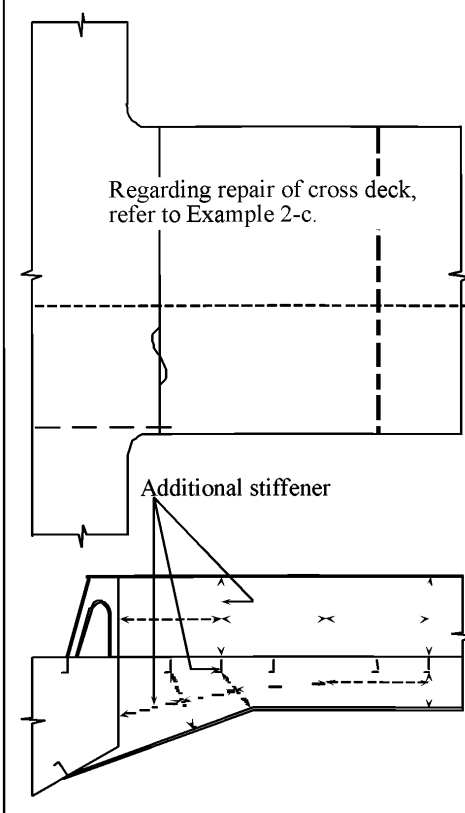
BULK CARRIERS		Guidelines for Surveys, Assessment and Repair of Hull Structure	
Part 1	Cargo hold region	Example No.	
Area 1	Deck structure	7-a	
Detail of damage		Buckling of hatch coaming and hatch end beam	
Sketch of damage		Sketch of repair

<p>Regarding buckling of deck, refer to Example 2-b and 2-c.</p> <p>Hatch end coaming</p> <p>Buckling</p> <p>Hatch end coaming stay</p> <p>Stiffener</p> <p>Hatch end beam</p> <p>No buckling here in Example 2-b</p>

<p>Regarding repair of cross deck, refer to Example 2-c.</p> <p>Additional stiffener</p>	
Notes on possible cause of damage		Notes on repairs	
<ol style="list-style-type: none"> 1. Additional transverse forces due to heavy seas, and torsional loading. 2. Inadvertent overloading of cargo spaces. 		<ol style="list-style-type: none"> 1. If buckling is due to loss in strength induced by corrosion, the buckled zone to be cropped and renewed as necessary. 2. If buckling results from inadequate strength, stiffeners should be fitted in addition to cropping and renewal of buckled zone.

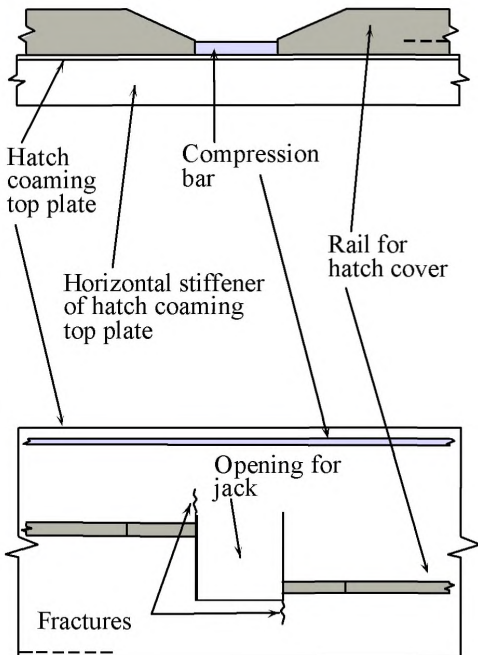
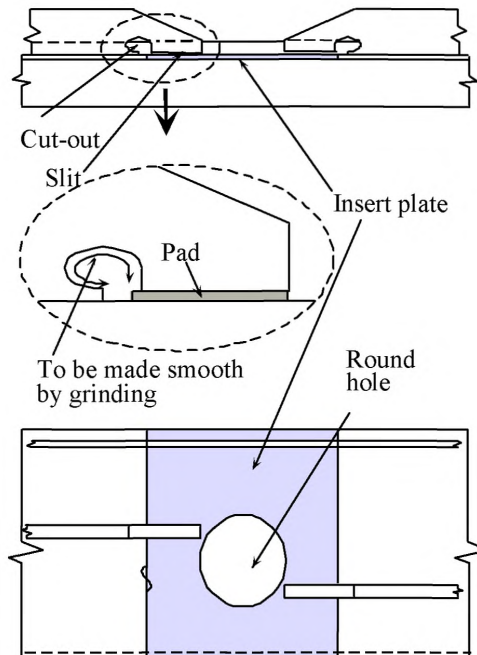
<p>Hatch coaming top plate</p> <p>Horizontal stiffener of hatch coaming top plate</p> <p>Compression bar</p> <p>Rail for hatch cover</p> <p>Opening for jack</p> <p>Fractures</p>		Sketch of repair

<p>Cut-out</p> <p>Slit</p> <p>Insert plate</p> <p>Pad</p> <p>To be made smooth by grinding</p> <p>Round hole</p>
Notes on possible cause of damage <ol style="list-style-type: none"> 1. Stress concentration at the termination of the rail for hatch cover due to poor design of opening. 		Notes on repairs <ol style="list-style-type: none"> 1. Fractured plate is to be cropped and part renewed. 2. Thicker insert plate and/or reduction of stress concentration adopting large radius should be considered. Or cut-out in the rail and detachment of the welds as shown in the above drawing should be considered in order to reduce the stress of the corner of the opening.

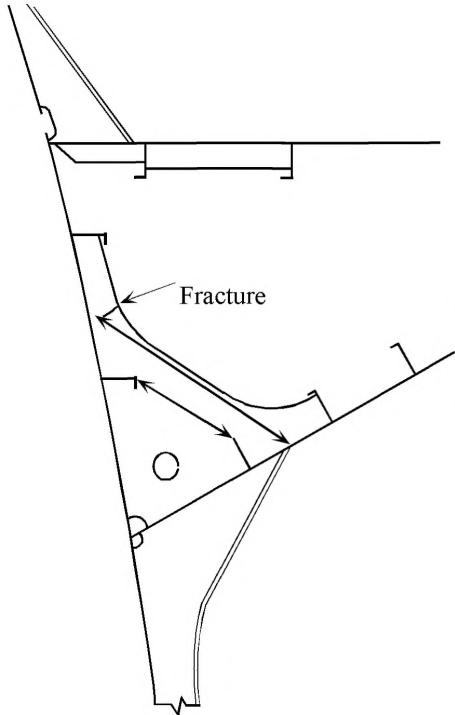
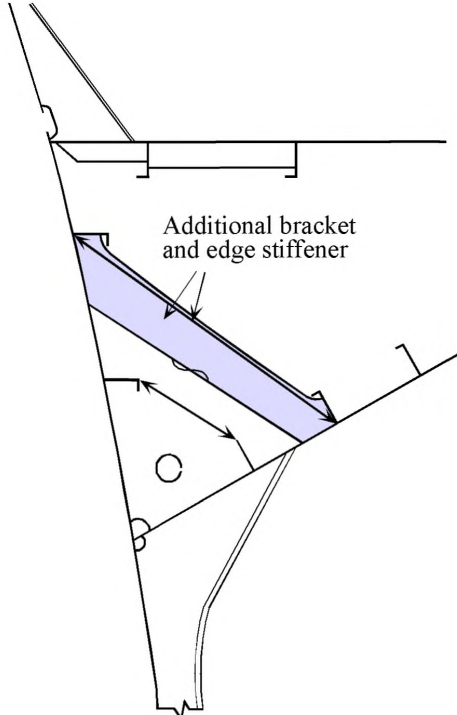
Notes on possible cause of damage		Notes on repairs
<ol style="list-style-type: none"> 1. Insufficient strength. 2. Corrosion. 		<ol style="list-style-type: none"> 1. Fractured part to be cropped and renewed. 2. If the fractured part is free from corrosion, increased size and thickness should be considered. Partial renewal of the bracket may be accepted depending on the nature of the fracture.

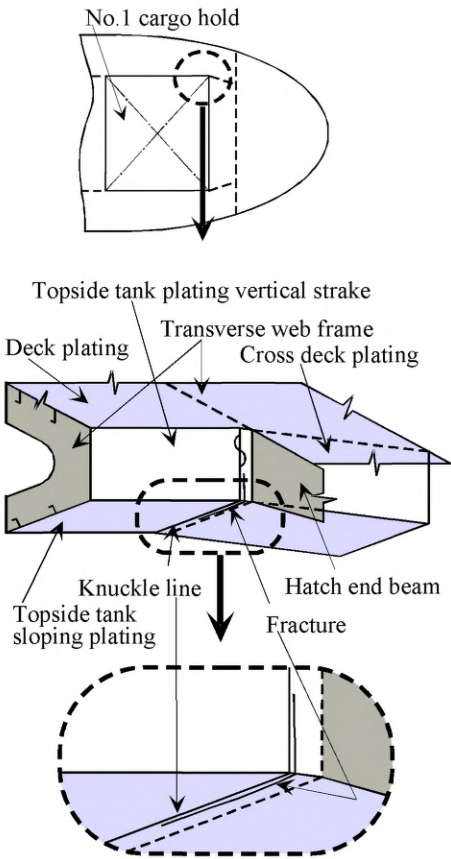
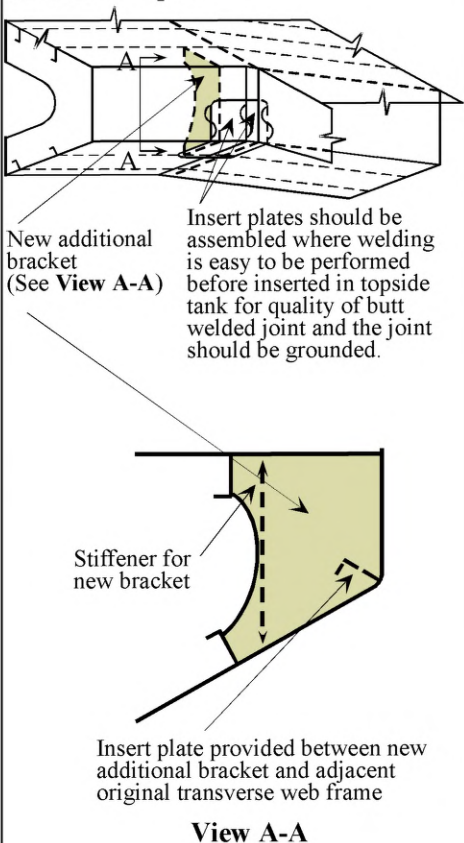
Notes on possible cause of damage 1. Insufficient strength. 2. Additional stress induced by knuckle.		Notes on repairs 1. Knuckle part should be reinforced appropriately.

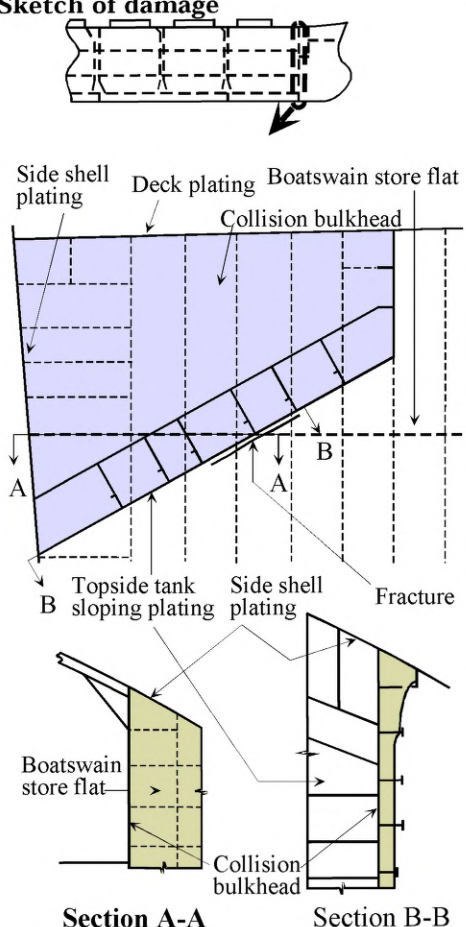
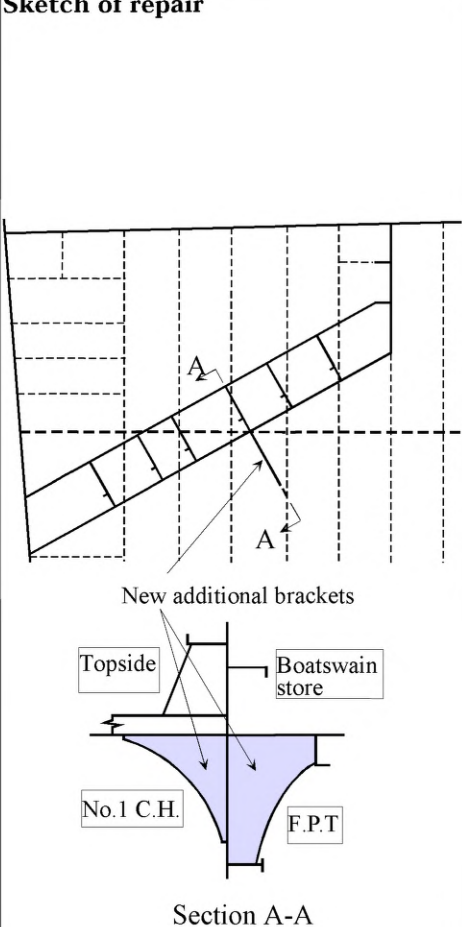
Notes on possible cause of damage 1. Damage caused by hard spot at intersection of the topside tank sloping plating and boatswain's store deck plating (fore peak tank top plating).		Notes on repairs 1. Fractured plates to be cropped and renewed. 2. Stress concentration should be considered (Brackets were fitted on both sides for reinforcement).

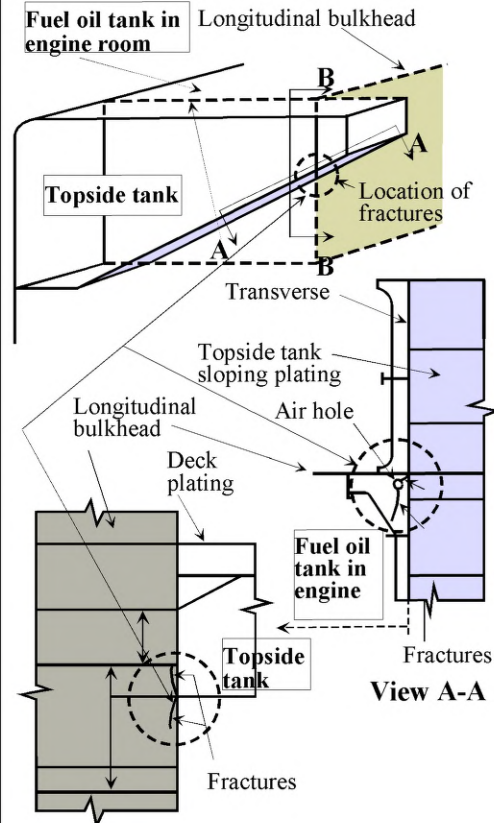
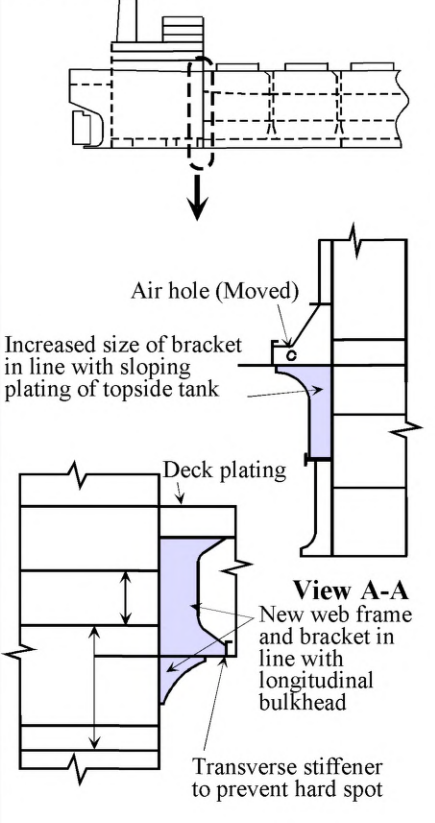
Notes on possible cause of damage		Notes on repairs	
1. Damage caused by hard spot at intersection of the topside tank sloping plating and longitudinal bulkhead of the fuel oil tank in engine room.		1. Fractured plates to be cropped and renewed as necessary and reinforcement fitted as shown shaded above. The position of the air-hole to be relocated.

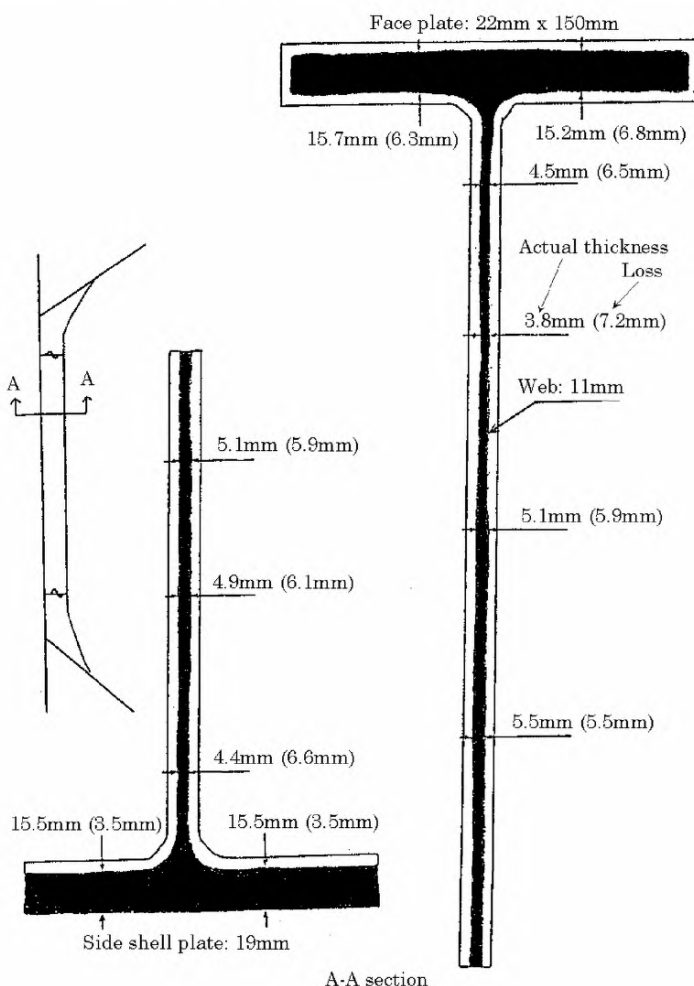
Figure 5 Uniform corrosion of side shell frame

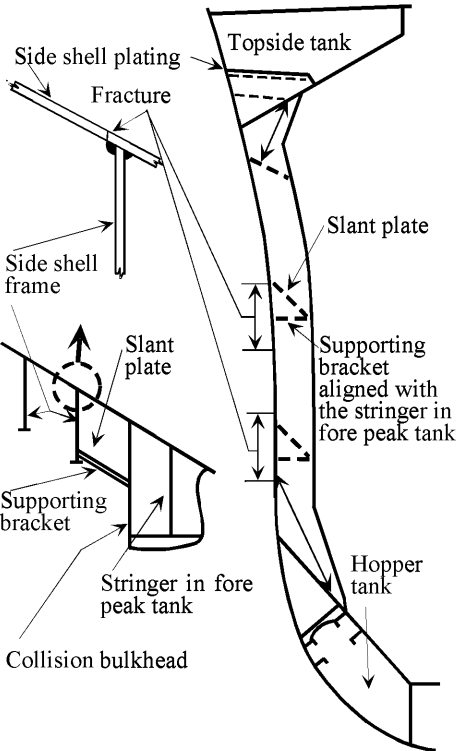
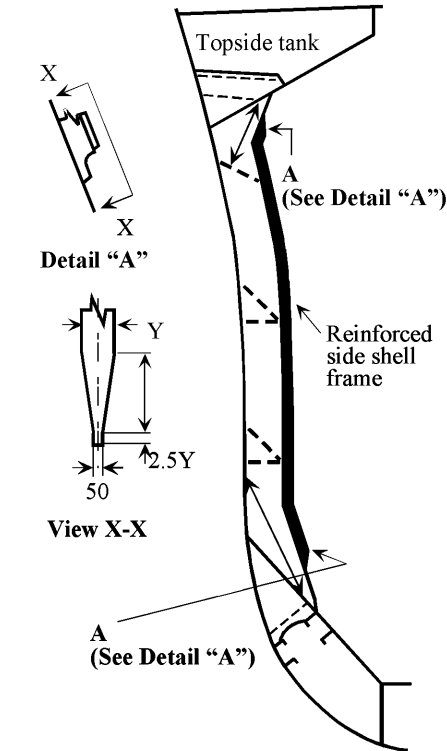
Notes on possible cause of damage <ol style="list-style-type: none"> 1. Damage caused by stress concentration leading to fatigue fracture in side shell. This has been exacerbated because of the greater flexibility of the hold structure in relation to the structure forward of the collision bulkhead. 		Notes on repairs <ol style="list-style-type: none"> 1. Fractured shell plates to be cropped and part renewed, and side shell frame/frames in the vicinity of the damage to be reinforced as required by the relevant Classification Society.

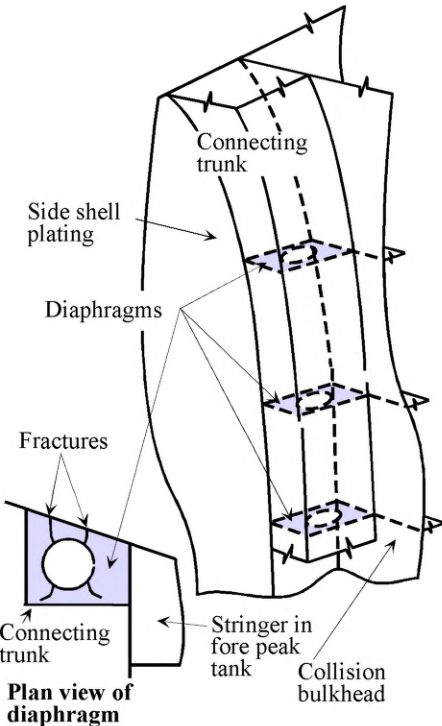
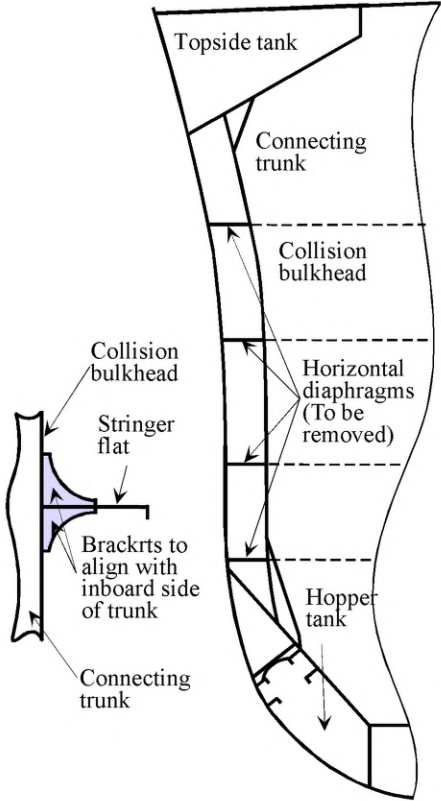
Notes on possible cause of damage 1. Damage caused by stress concentration resulting from the discontinuity created by the trunk and diaphragm structure. This has been exacerbated because of the greater flexibility of the hold structure in relation to the trunk and structure forward of the collision bulkhead.		Notes on repairs 1. Diaphragm to be removed permanently and fractured shell plated cropped and part renewed, or veed and weld as necessary in way of damage. Brackets with softened toes are to be fitted on forward side of collision bulkhead in way of stringers/flats to align with inboard side of trunk in order to remove hard-spots.

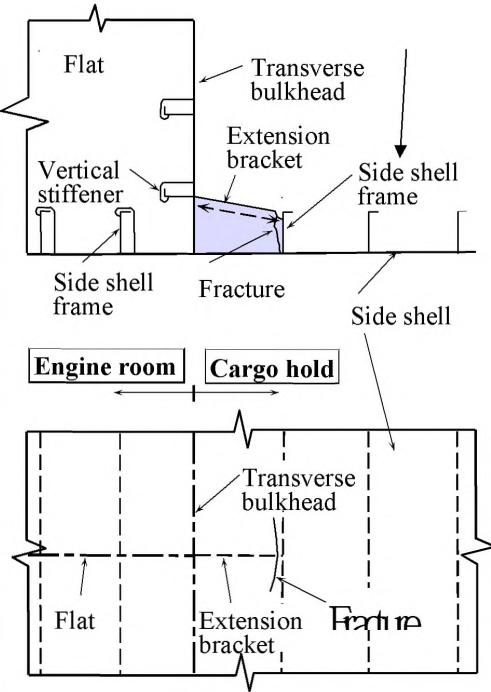
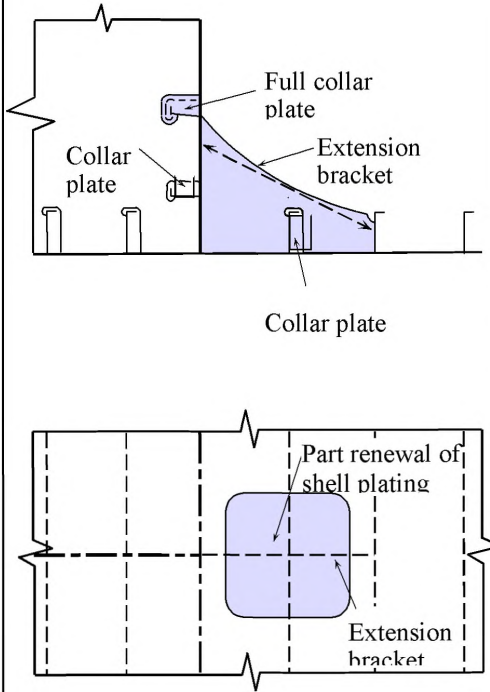
Notes on possible cause of damage 1. Damage caused by stress concentration leading to fatigue fracture on side shell. This will be exacerbated because of the greater flexibility of the hold structure in relation to the engine room structure.		Notes on repairs 1. The fractured shell plating is to be cropped and part renewed as necessary. 2. Extension bracket is to be modified and collar plates to cut-outs in engine room flat are to be installed.

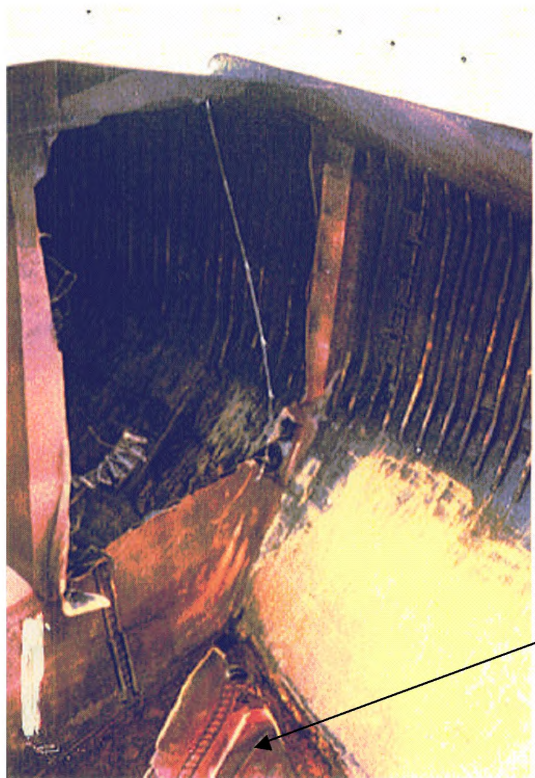
Photograph 1
Collapsed and detached
transverse bulkhead

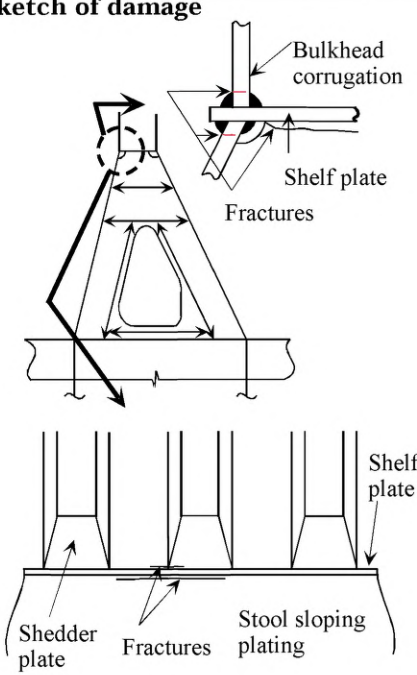
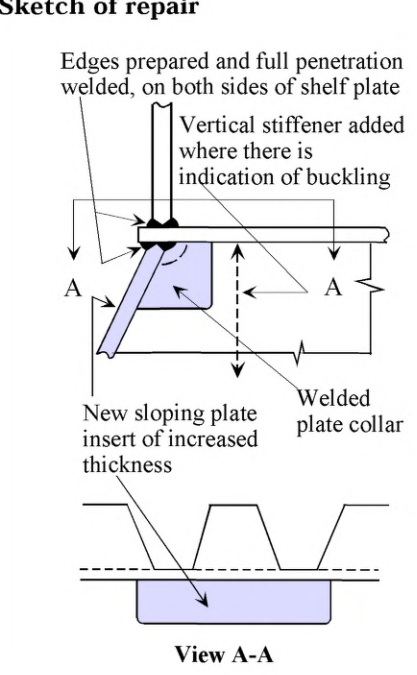
<p>The sketch shows a side view of a bulkhead with corrugation. A shelf plate is attached to the bulkhead, and fractures are indicated at the weld connections. Below, a detail view shows the shedder plate, stool sloping plating, and shelf plate, with fractures at the welds.</p>		Sketch of repair

<p>The repair sketch shows the bulkhead corrugation with edges prepared and full penetration welded on both sides of the shelf plate. A vertical stiffener is added where there is indication of buckling. A new sloping plate insert of increased thickness is shown, along with a welded plate collar. View A-A shows the cross-section of the repair.</p>

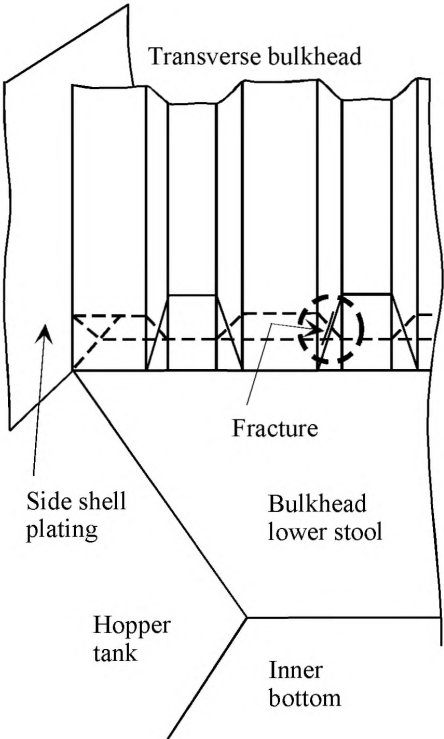
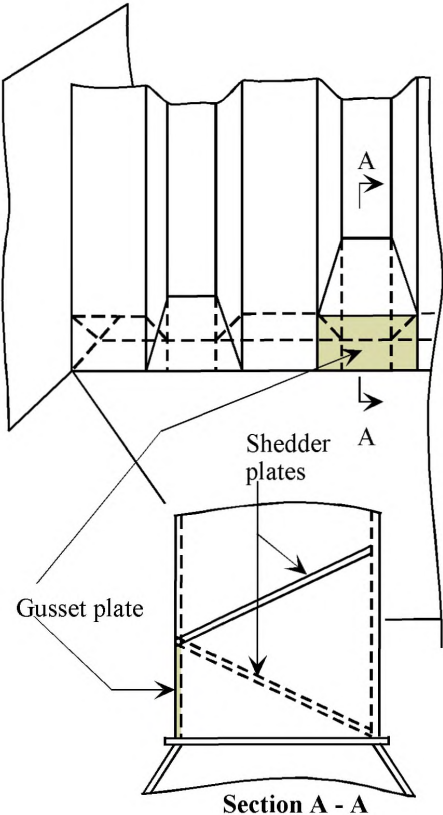
<p>Transverse bulkhead</p> <p>Fracture</p> <p>Side shell plating</p> <p>Bulkhead lower stool</p> <p>Hopper tank</p> <p>Inner bottom</p>

<p>Shedder plates</p> <p>Gusset plate</p> <p>Section A - A</p>
Notes on possible cause of damage		Notes on repairs
<ol style="list-style-type: none"> 1. Damage due to stress concentrations at intersection of shedder plates. This can be exacerbated by corrosion and reduction in thickness of the corrugation web plating. 		<ol style="list-style-type: none"> 1. If due to wastage, corrugation plating and shedder plates to be part renewed/renewed as necessary. 2. Where renewals are being carried out it may be prudent to fit the extension pieces shown above to change the location of the point of intersection, and hence reduce the stress concentration.

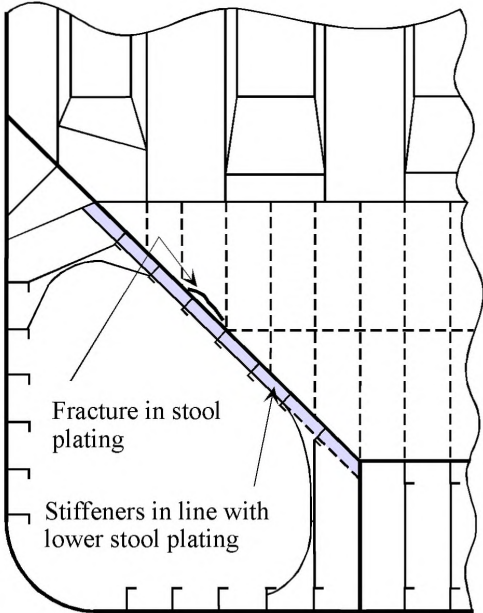
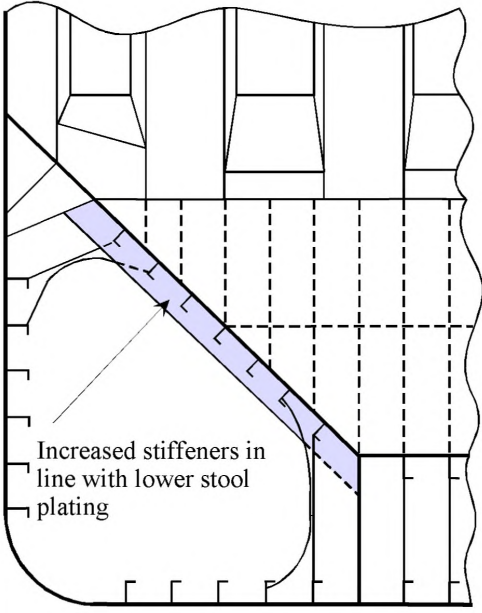
<p>Fracture in stool plating</p> <p>Stiffeners in line with lower stool plating</p>

<p>Increased stiffeners in line with lower stool plating</p>
Notes on possible cause of damage		Notes on repairs
<ol style="list-style-type: none"> 1. Insufficient strength of the connection 2. Corrosion 		<ol style="list-style-type: none"> 1. Fractured stool plating should be partly cropped and renewed (thicker plate) if considered necessary. 2. If the damage occurred due to insufficient strength, stiffeners in line with stool plating should be increased.

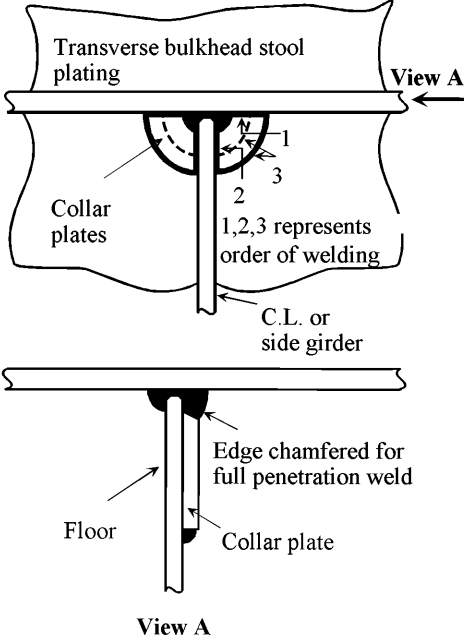
Notes on possible cause of damage 1. Stress concentration at the welds due to scallops.		Notes on repairs 1. The scallops will require to be fitted with welded collar plates to reduce stresses in the area.

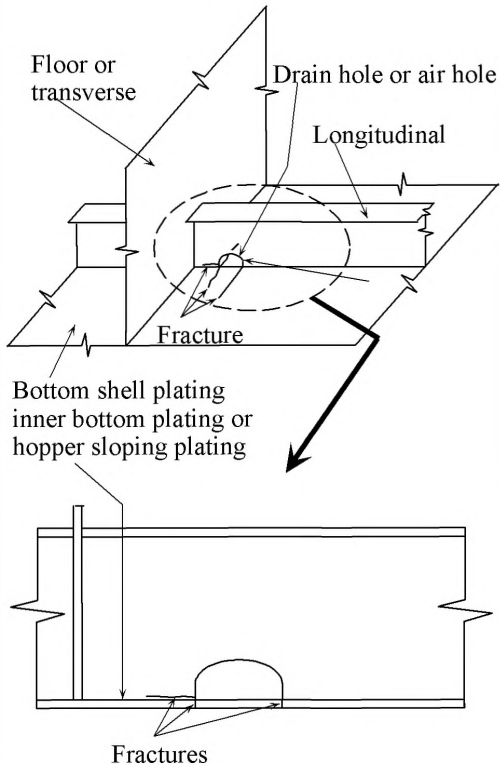
Notes on possible cause of damage		Notes on repairs
<ol style="list-style-type: none"> 1. Stress concentration and/or corrosion due to stress concentration at the corner of drain hole/air hole. 		<ol style="list-style-type: none"> 1. Fractured plating should be cropped and part renewed. 2. If fatigue life is to be improved, change of drain hole/air hole shape is to be considered.

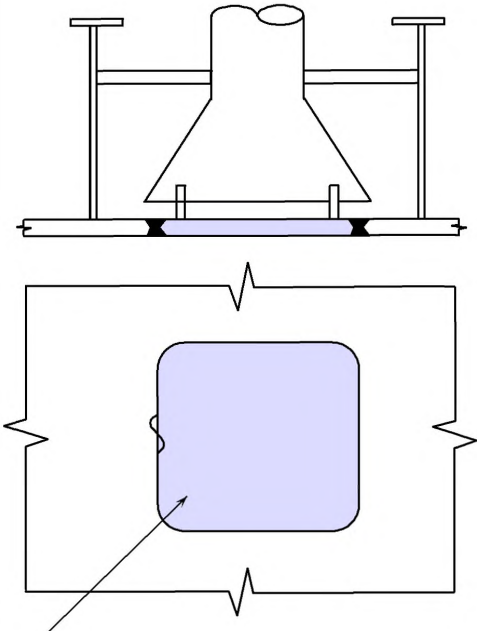
<p>1. Insert to have round corners 2. Non-destructive examination to be applied after welding based on the Society's rules</p>
Notes on possible cause of damage <ol style="list-style-type: none"> 1. High flow rate associated with insufficient corrosion prevention system. 2. Galvanic action between dissimilar metals. 		Notes on repairs <ol style="list-style-type: none"> 1. Affected plating should be cropped and part renewed. Thicker plate and suitable beveling should be considered. 2. If the corrosion is limited to a small area, i. e. pitting corrosion, repair by welding is acceptable.

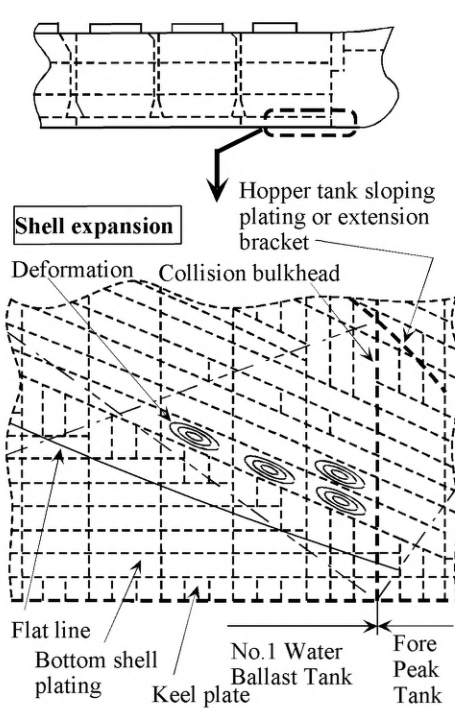
Notes on possible cause of damage		Notes on repairs
<ol style="list-style-type: none"> Heavy weather. Poor design for slamming. Poor operation, i.e. negligence of heavy ballast. 		<ol style="list-style-type: none"> Deformed bottom shell plating should be faired in place, or partly cropped and renewed if considered necessary. Bottom shell plating should be reinforced by stiffeners.

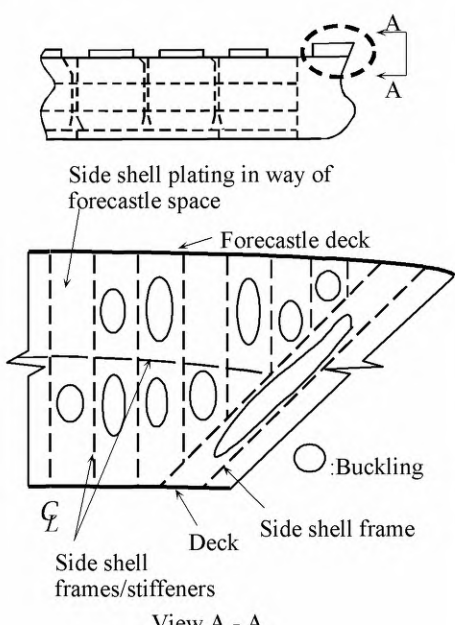
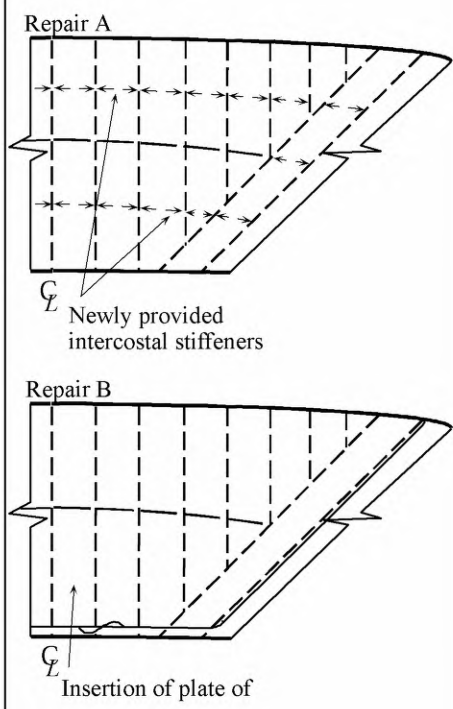
<p>Side shell plating in way of forecastle space</p> <p>Forecastle deck</p> <p>Deck</p> <p>Side shell frame</p> <p>Side shell frames/stiffeners</p> <p>View A - A</p> <p>○: Buckling</p>

<p>Repair A</p> <p>Newly provided intercostal stiffeners</p> <p>Repair B</p> <p>Insertion of plate of</p>
Notes on possible cause of damage		Notes on repairs
<ol style="list-style-type: none"> 1. Heavy weather. 2. Insufficient strength. 		<ol style="list-style-type: none"> 1. Deformed part should be cropped and part renewed. 2. Repair A Additional stiffeners between existing stiffeners should be considered. Repair B Insertion of plate of increased thickness with additional stiffeners.

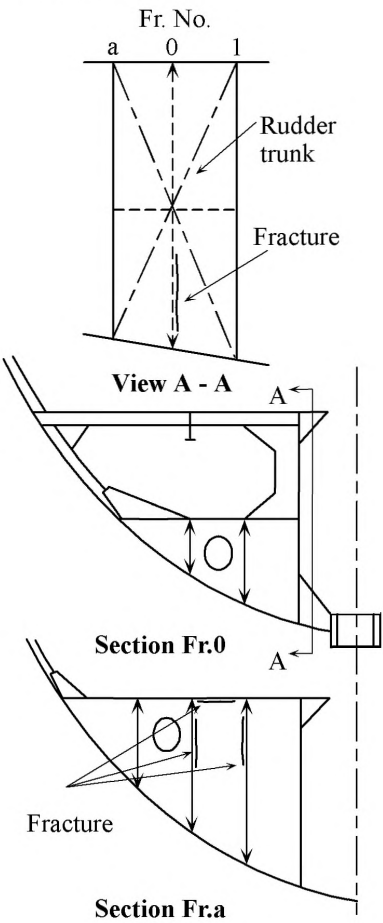
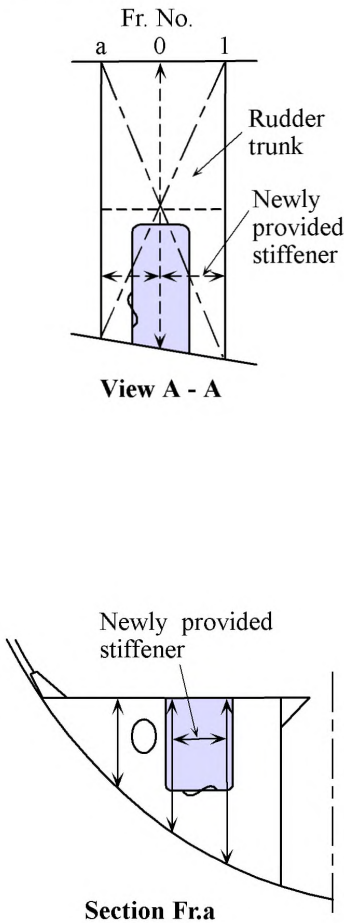
<p>Fr. No. 0</p> <p>a 0 1</p> <p>Rudder trunk</p> <p>Fracture</p> <p>View A - A</p> <p>Section Fr.0</p> <p>Section Fr.a</p>		Sketch of repair

<p>Fr. No. 1</p> <p>a 0 1</p> <p>Rudder trunk</p> <p>Newly provided stiffener</p> <p>View A - A</p> <p>Newly provided stiffener</p> <p>Section Fr.a</p>
Notes on possible cause of damage 1. Vibration.		Notes on repairs 1. The fractured plating should be cropped and renewed. 2. Natural frequency of the plate between stiffeners should be changed, e.g. reinforcement by additional stiffeners.

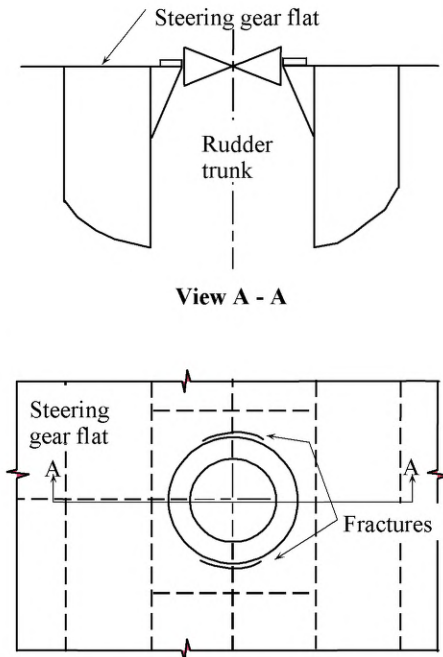
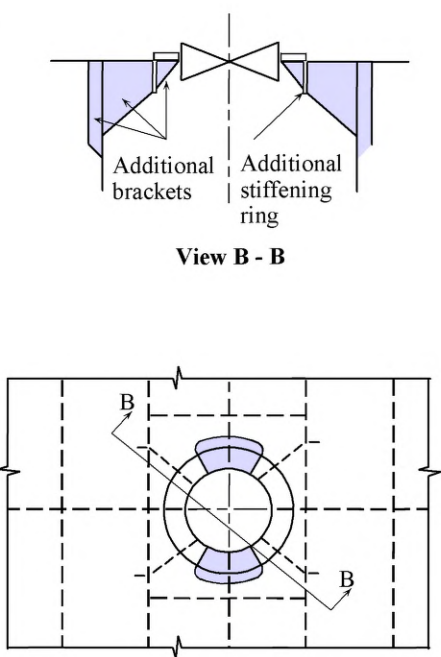
Notes on possible cause of damage 1. Inadequate design.		Notes on repairs 1. Fractured plating should be cropped and renewed. 2. Additional brackets and stiffening ring should be fitted for reinforcement.

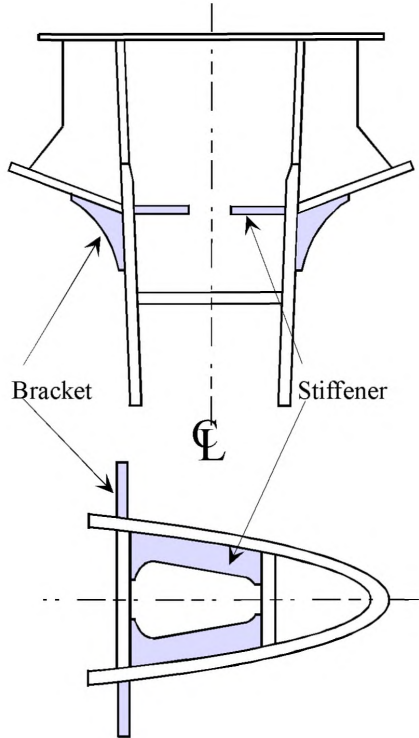
Notes on possible cause of damage		Notes on repairs
<ol style="list-style-type: none"> 1. Insufficient strength due to poor design. 		<ol style="list-style-type: none"> 1. Fractured plating to be veed-out and rewelded. 2. Fractured plating to be cropped and renewed if considered necessary. 3. Reinforcement should be considered if considered necessary.

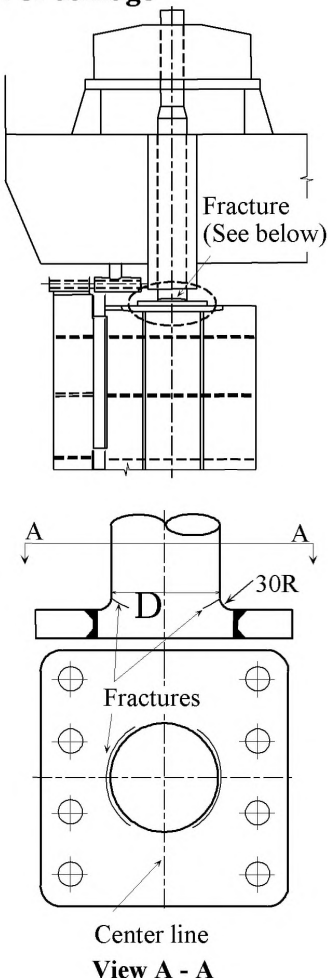
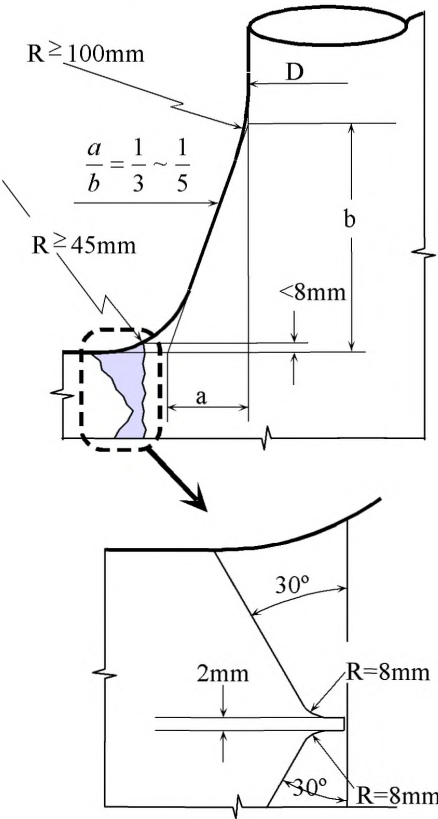
<p>Fracture (See below)</p> <p>Center line View A - A</p>

<p>$R \geq 100\text{mm}$</p> <p>$\frac{a}{b} = \frac{1}{3} \sim \frac{1}{5}$</p> <p>$R \geq 45\text{mm}$</p> <p>$D$</p> <p>$b$</p> <p>$< 8\text{mm}$</p> <p>$a$</p> <p>$30^\circ$</p> <p>$2\text{mm}$</p> <p>$R=8\text{mm}$</p> <p>$30^\circ$</p> <p>$R=8\text{mm}$</p>
Notes on possible cause of damage		Notes on repairs
1. Inadequate design for stress concentration in rudder stock.		1. Modification of detail design of rudder stock to reduce the stress concentration.

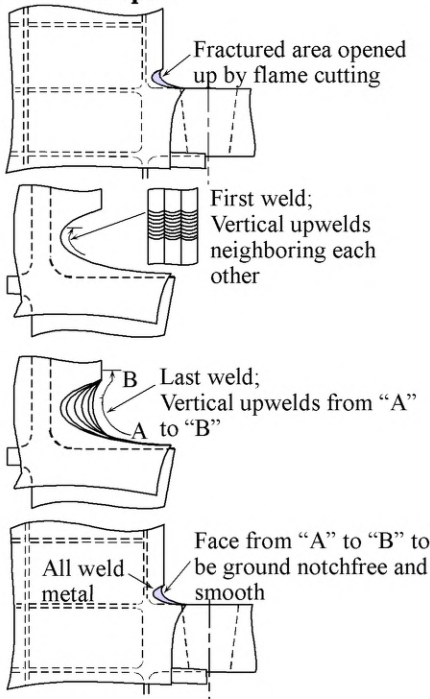
Notes on possible cause of damage		Notes on repairs
<ol style="list-style-type: none"> 1. Stress concentration due to inadequate local design and/or fabrication notches in way of the butt weld between cast piece and plating. 		<ol style="list-style-type: none"> 1. Grooving-out and welding of the fracture is not always adequate (metallurgical notch in way of a high stressed area). 2. In the proposed repair procedure the metallurgical notches are shifted into a zone exposed to lower stresses. 3. After welding a modification of the radius according to the proposal in Example 5 is to be carried out. 4. In case of very small crack it can be ground off by increasing the radius.

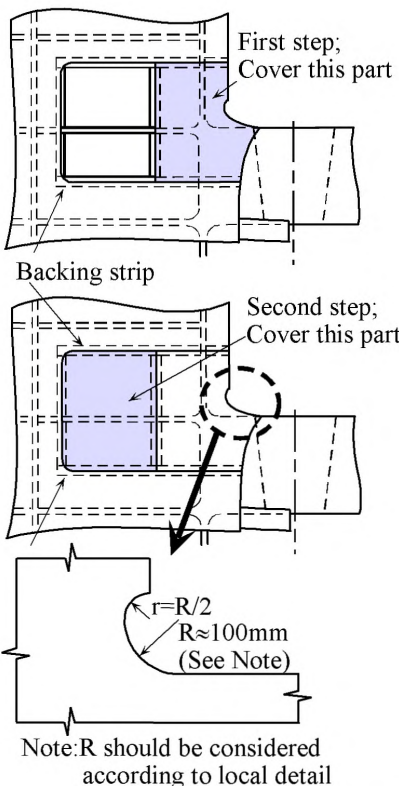
Notes on possible cause of damage		Notes on repairs
<ol style="list-style-type: none"> 1. Stress concentration due to inadequate local design and/or fabrication notches in way of the butt weld between cast piece and plating. 		<ol style="list-style-type: none"> 1. Fractured plating is to be cut-out. 2. Internal structures are to be checked. 3. Cut-out is to be closed by an insert plating according to the sketch (welding only from one side is demonstrated). 4. Modification of the radius. 5. In case of a new cast piece, connection with the plating is to be shifted outside the high stress area.

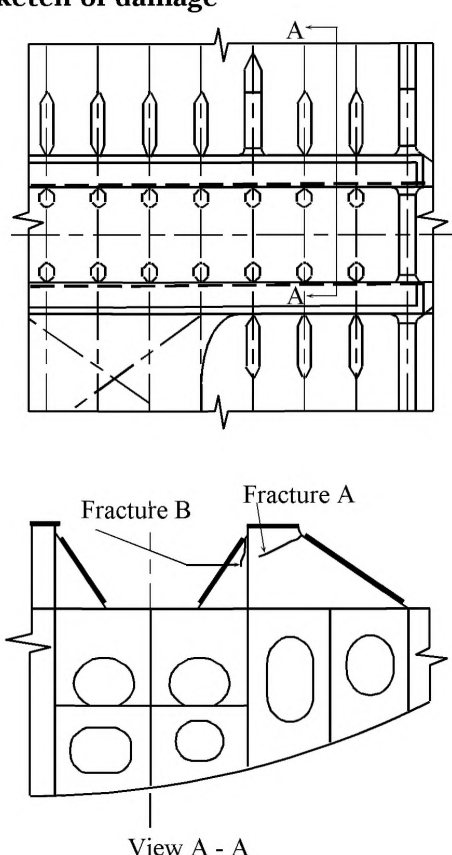
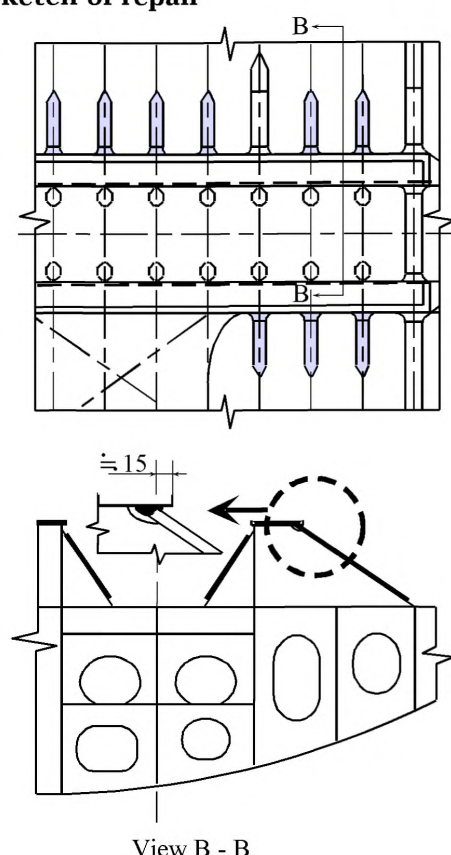
<p>View B - B</p>	
Notes on possible cause of damage		Notes on repairs	
<ol style="list-style-type: none"> 1. Vibration of main engine. 2. Insufficient strength of brackets at main engine foundation. 3. Insufficient pre-load bolts. 		<ol style="list-style-type: none"> 1. Fractures are to be veed-out and rewelded. 2. New modified brackets at main engine foundation. 3. Or insert pieces and additional flanges to increase section modulus of the brackets.

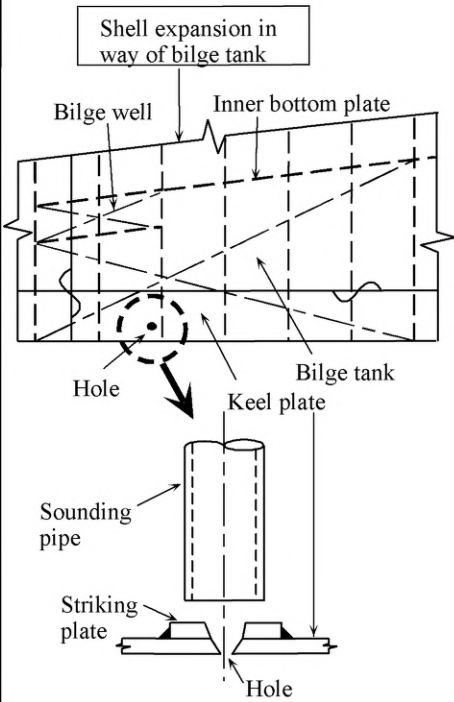
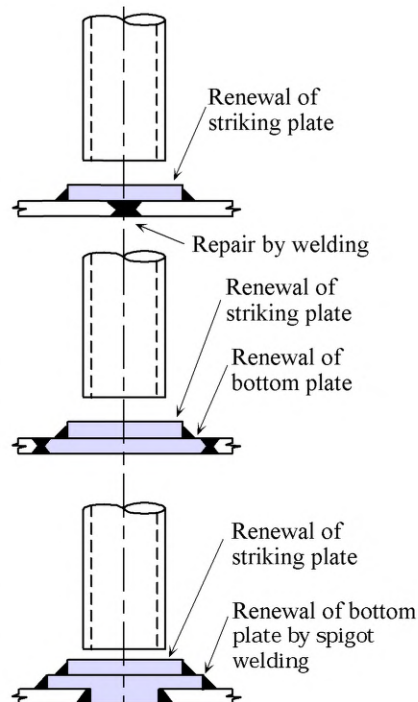
Notes on possible cause of damage 1. Heavy corrosion of bottom plating under sounding pipe.		Notes on repairs 1. Corroded striking plating should be renewed. 2. Bottom plate should be repaired depending on the condition of corrosion. (Note) Repair by spigot welding can be applied to the structure only when the stress level is considerably low. Generally this procedure cannot be applied to the repair of bottom plating of ballast tanks in cargo hold region.

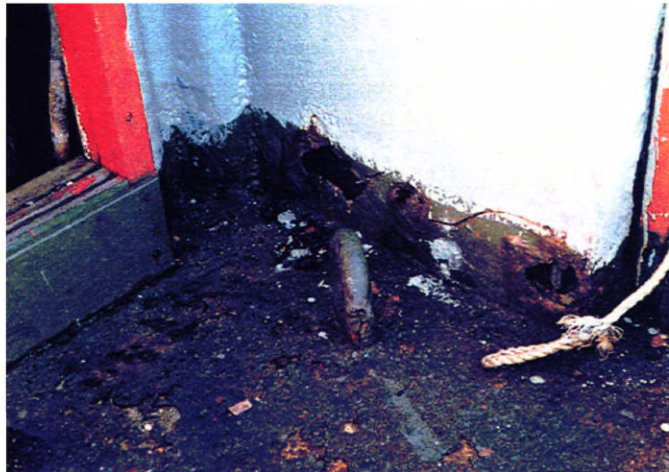
Photograph 1 Corroded accommodation house side structure
