No.76 IACS Guidelines for Surveys, Assessment and Repair of Hull Structure – Bulk Carriers

(1994)
(Rev.1
July 2001)
(Rev.2
June 2004)
(Corr.1
Sept 2007)

BULK CARRIERS

Guidelines for Surveys, Assessment and Repair of Hull
Structure

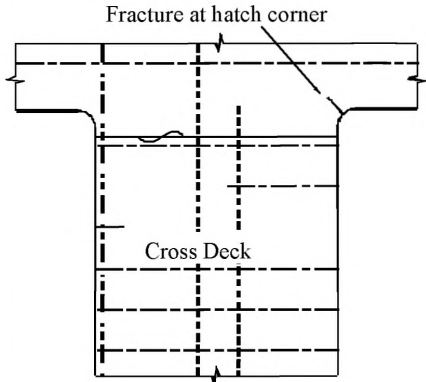
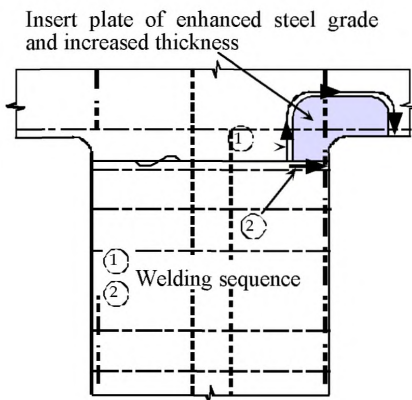
BULK CARRIERS		Guidelines for Surveys, Assessment and Repair of Hull Structure	
Part 1	Cargo hold region	Example No.	
Area 1	Deck structure	1	
Detail of damage		Fractures at main cargo hatch corner	
Sketch of damage

Notes on possible cause of damage <ol style="list-style-type: none"> 1. Stress concentration at hatch corners, i.e. radius of corner. 2. Welded attachment of shedder plate close to edge of hatch corner. 3. Wire rope groove. 		Notes on repairs <ol style="list-style-type: none"> 1. The corner plating in way of the fracture is to be cropped and renewed. If stress concentration is primary cause, insert plate should be increased thickness, enhanced steel grade and/or improved geometry. Insert plate should be continued beyond the longitudinal and transverse extent of the hatch corner radius ellipse or parabola, and the butt welds to the adjacent deck plating should be located well clear of the butts in the hatch coaming. It is recommended that the edges of the insert plate and the butt welds connecting the insert plates to the surrounding deck plating be made smooth by grinding. In this respect caution should be taken to ensure that the micro grooves of the grinding are parallel to the plate edge. 2. If the cause of fracture is welded attachment of shedder plate, the deck connection should be left unwelded. 3. If the cause of the fracture is wire rope groove, replacement to the original design can be accepted.

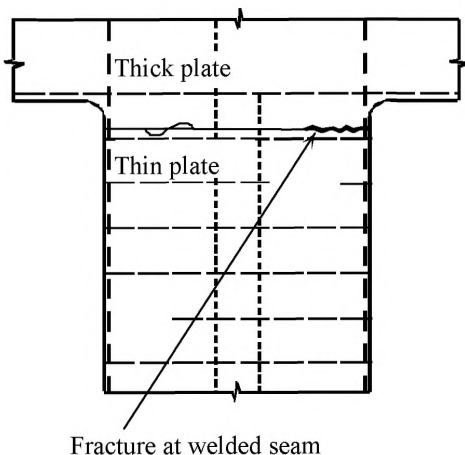
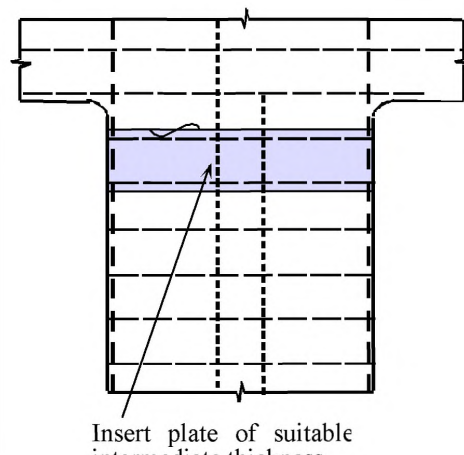
BULK CARRIERS		Guidelines for Surveys, Assessment and Repair of Hull Structure	
Part 1	Cargo hold region	Example No.	
Area 1	Deck structure	2-a	
Detail of damage		Fractures of welded seam between thick plate and thin plate at cross deck	
Sketch of damage

Notes on possible cause of damage <ol style="list-style-type: none"> 1. Stress concentration created by abrupt change in deck plating thickness. 2. In-plane bending in cross deck strip due to torsional (longitudinal) movements of ship sides. 3. Welded seam not clear of tangent point of hatch corner. 		Notes on repairs <ol style="list-style-type: none"> 1. Insert plate of intermediate thickness is recommended. 2. Smooth transition between plates (beveling) should be considered.

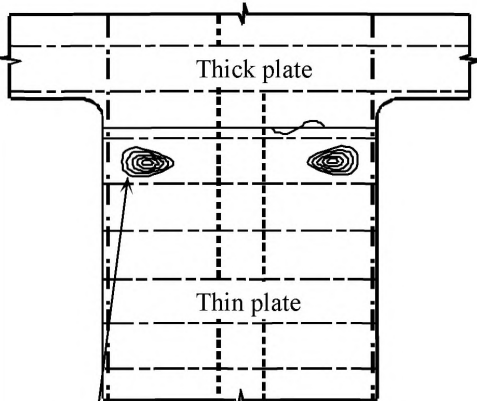
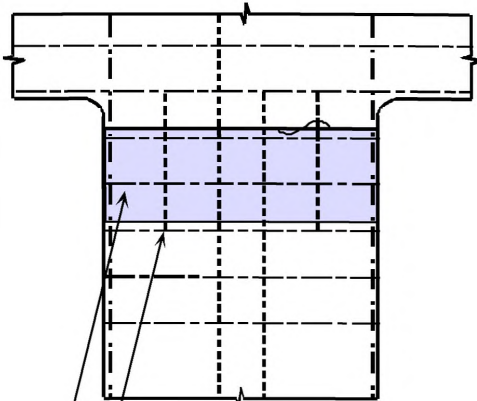
BULK CARRIERS		Guidelines for Surveys, Assessment and Repair of Hull Structure	
Part 1	Cargo hold region	Example No.	
Area 1	Deck structure	2-b	
Detail of damage		Plate buckling in thin plate near thick plate at cross deck	
Sketch of damage

<p>Buckling of cross deck plating (Buckling of hatch end structure should be examined. Refer to Example 7-a.)</p>		Sketch of repair

<p>Additional transverse stiffening and/or insertion of plate with suitable intermediate thickness</p>	
Notes on possible cause of damage <ol style="list-style-type: none"> 1. In-plane bending of cross deck strip due to torsional (longitudinal) movement of ship sides, often in combination with corrosion. 2. Insufficient plate thickness and/or transverse stiffening. 		Notes on repairs <ol style="list-style-type: none"> 1. Transverse stiffeners extending from hatch sides towards centerline at least 10% of breadth of hatch, and/or increased plate thickness in the same area.

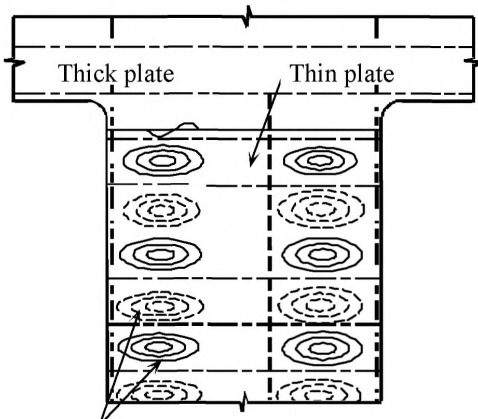
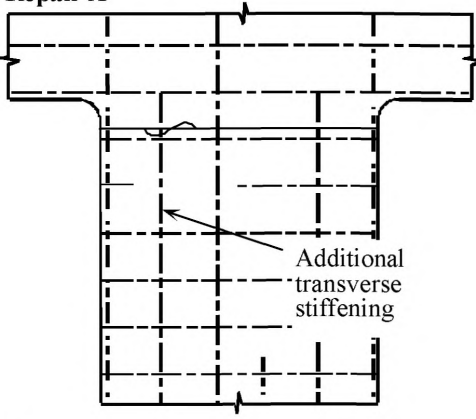
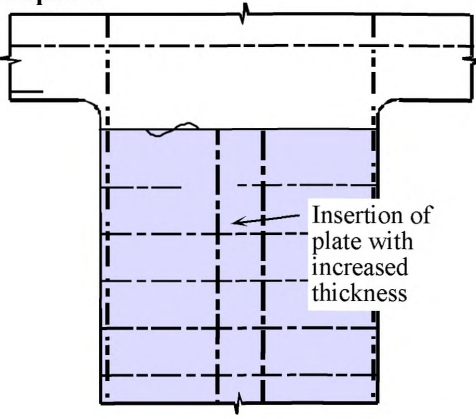
BULK CARRIERS		Guidelines for Surveys, Assessment and Repair of Hull Structure	
Part 1	Cargo hold region		Example No.
Area 1	Deck structure		2-c
Detail of damage		Overall buckling of cross deck plating	
Sketch of damage

<p>Buckling of cross deck plating (Buckling of hatch end structure should be examined. Refer to Example 7-a.)</p>		Sketch of repair <p>Repair A</p>

Notes on possible cause of damage <ol style="list-style-type: none"> 1. Transverse compression of deck due to sea load. 2. Transverse compression of deck due to excessive loading in two adjacent holds. 3. Insufficient plate thickness and/or transverse stiffening. 		Notes on repairs <ol style="list-style-type: none"> 1. Repair A Plating of original thickness in combination with additional transverse stiffening. 2. Repair B Insertion of plating of increased thickness.

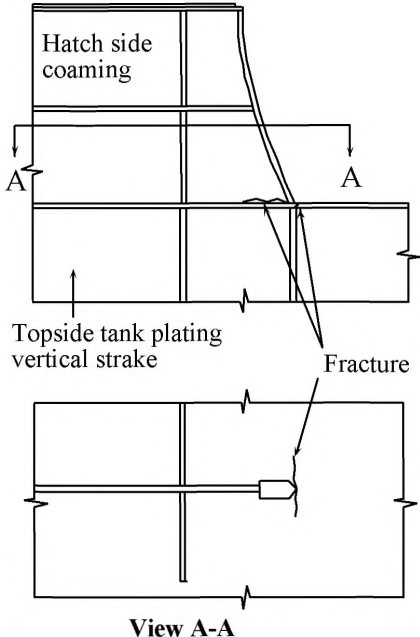
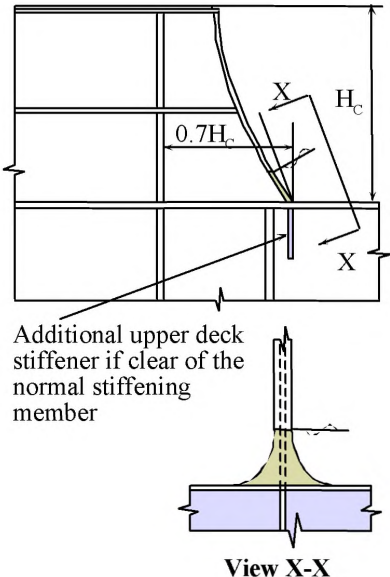
BULK CARRIERS		Guidelines for Surveys, Assessment and Repair of Hull Structure
Part 1	Cargo hold region	Example No.
Area 1	Deck structure	3-a
Detail of damage		Fractures in the web or in the deck at the toes of the longitudinal hatch coaming termination bracket
Sketch of damage

Notes on possible cause of damage 1. This damage is caused by stress concentrations attributed to the design of the bracket.		Notes on repairs 1. The design of the bracket can be altered as shown above, however, it is to be ensured that an additional under deck stiffener is provided at the toe of the termination bracket, where the toe is clear of the normal stiffening member. 2. Full penetration weld for a distance of $0.15 H_C$ from toe of side coaming termination bracket and for connection of athwartship gusset bracket to deck. 3. The fracture in deck plating to be veed-out and rewelded or deck plating cropped and part renewed as appropriate, using low hydrogen electrodes for welding.

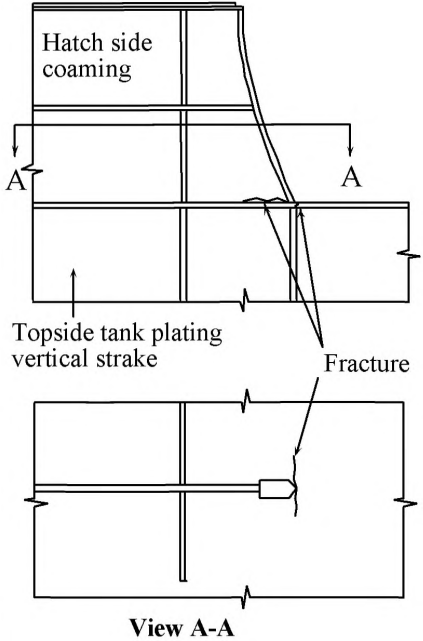
BULK CARRIERS		Guidelines for Surveys, Assessment and Repair of Hull Structure
Part 1	Cargo hold region	Example No.
Area 1	Deck structure	3-b
Detail of damage		Fractures in the web or in the deck at the toes of the longitudinal hatch coaming termination bracket
Sketch of damage

<p>Hatch side coaming</p> <p>Topside tank plating vertical strake</p> <p>Fracture</p> <p>View A-A</p>		Sketch of repair

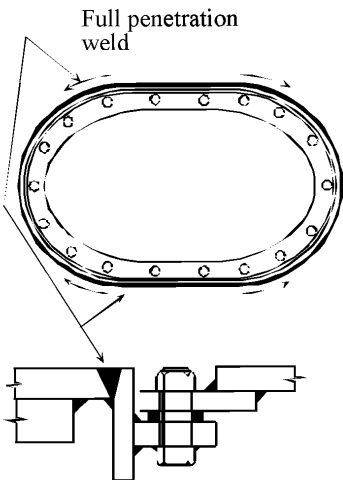
<p>Fractures</p> <p>Manhole</p> <p>Cross deck</p> <p>Fractures</p> <p>X-X</p> <p>Deck plating</p> <p>Doubling plate</p> <p>Continuous welding</p> <p>Joint A</p> <p>Section X-X</p>		Sketch of repair

<p>Full penetration weld</p>
Notes on possible cause of damage <ol style="list-style-type: none"> 1. Heavy weather. 2. Improper welding of joint "A". 		Notes on repairs <ol style="list-style-type: none"> 1. The fracture in deck plating to be veed-out and rewelded, or deck plating cropped and part renewed if considered necessary. 2. Full penetration of joint "A" should be considered.

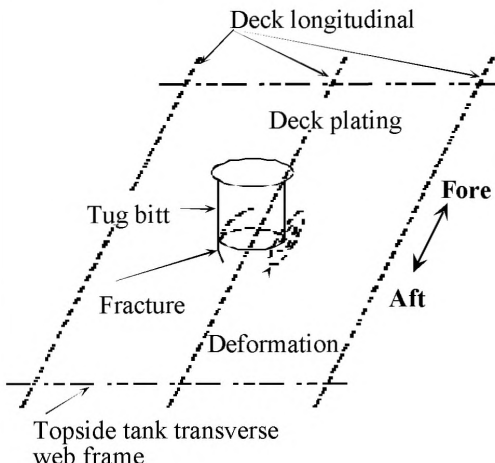
BULK CARRIERS		Guidelines for Surveys, Assessment and Repair of Hull Structure	
Part 1	Cargo hold region		Example No.
Area 1	Deck structure		5
Detail of damage		Deformed and fractured deck plating around tug bitt	
Sketch of damage		Sketch of repair

Notes on possible cause of damage		Notes on repairs	
<ol style="list-style-type: none"> Insufficient strength 		<ol style="list-style-type: none"> Fractured/deformed deck plating should be cropped and part renewed. Reinforcement by stiffeners should be considered.

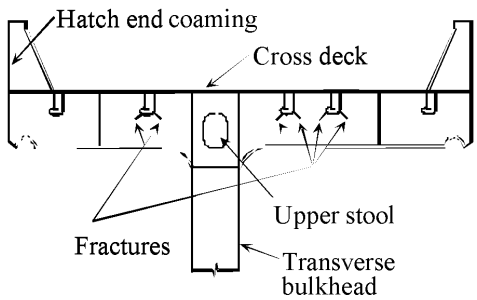
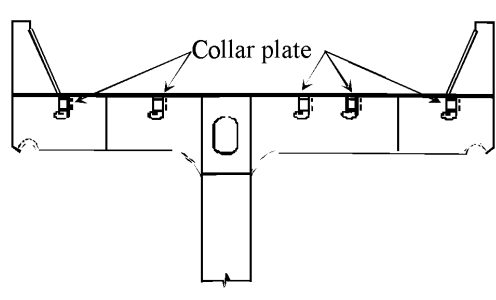
BULK CARRIERS		Guidelines for Surveys, Assessment and Repair of Hull Structure	
Part 1	Cargo hold region		Example No.
Area 1	Deck structure		6
Detail of damage		Fractures around cut-outs in cross deck girder	
Sketch of damage

Notes on possible cause of damage 1. Stress concentration at the cut-outs in cross deck girder.		Notes on repairs 1. Fractured web plate of cross deck girder to be cropped and part renewed. 2. Collar plates to be provided.

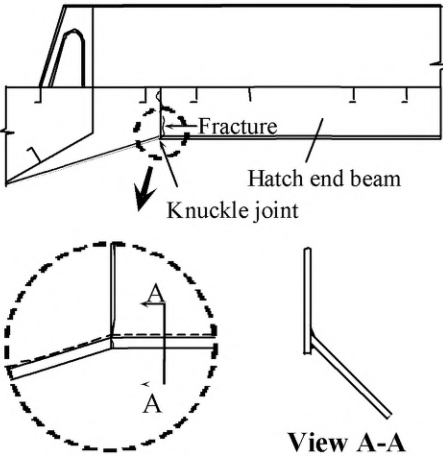
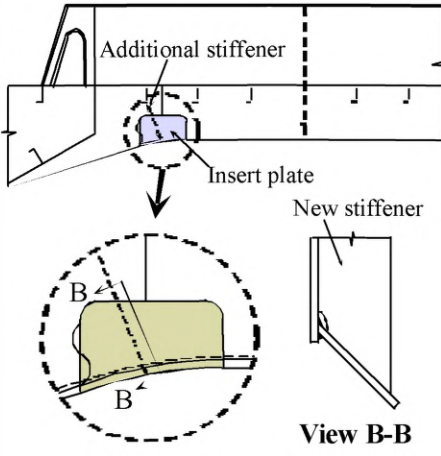
BULK CARRIERS		Guidelines for Surveys, Assessment and Repair of Hull Structure	
Part 1	Cargo hold region		Example No.
Area 1	Deck structure		7-b
Detail of damage		Fractures in hatch end beam at knuckle joint	
Sketch of damage

Notes on possible cause of damage 1. Stress concentration at knuckle joint.		Notes on repairs 1. Fractured part to be cropped and renewed. 2. Improvement to avoid stress concentration at knuckle joint should be considered.

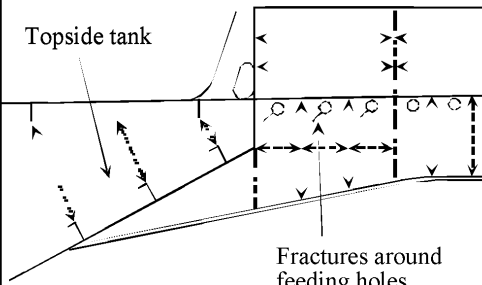
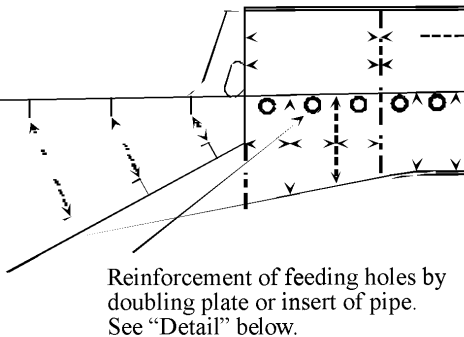
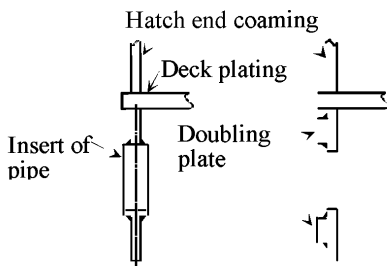
BULK CARRIERS		Guidelines for Surveys, Assessment and Repair of Hull Structure	
Part 1	Cargo hold region		Example No.
Area 1	Deck structure		9
Detail of damage		Fractures in hatch end beam around feeding holes	
Sketch of damage		Sketch of repair

Detail	
Notes on possible cause of damage		Notes on repairs	
<ol style="list-style-type: none">1. Inadequate reinforcement around feeding hole.2. Corrosion.		<ol style="list-style-type: none">1. Fractured part to be veed-out or cropped and renewed.2. If the fractured part is free from corrosion, reinforcement should be considered.

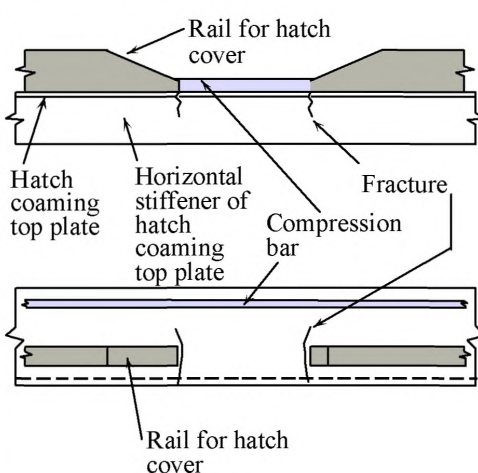
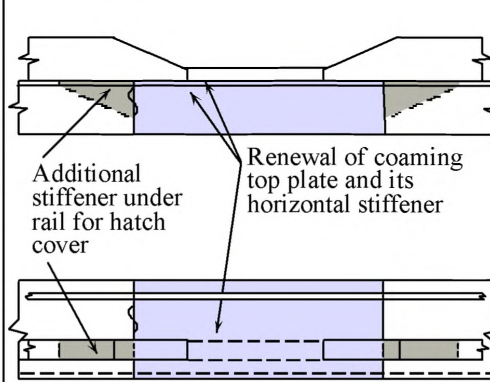
BULK CARRIERS		Guidelines for Surveys, Assessment and Repair of Hull Structure	
Part 1	Cargo hold region		Example No.
Area 1	Deck structure		10-a
Detail of damage		Fractures in hatch coaming top plate at the termination of rail for hatch cover	
Sketch of damage

Notes on possible cause of damage <ol style="list-style-type: none"> 1. Stress concentration at the termination of the rail for hatch cover due to poor design. 		Notes on repairs <ol style="list-style-type: none"> 1. Fractured plate is to be cropped and part renewed. 2. Thicker insert plate and/or reinforcement by additional stiffener under the top plate should be considered. Also refer to Example 10-b.

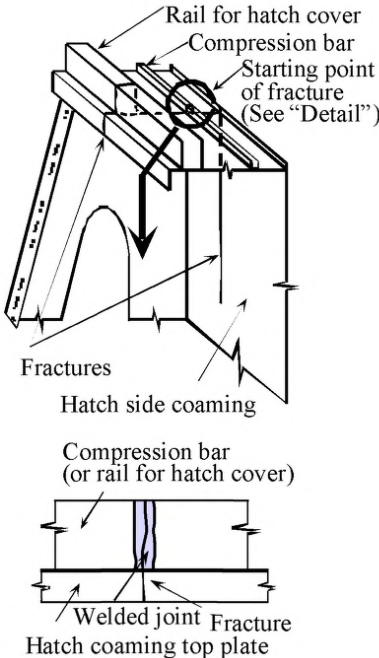
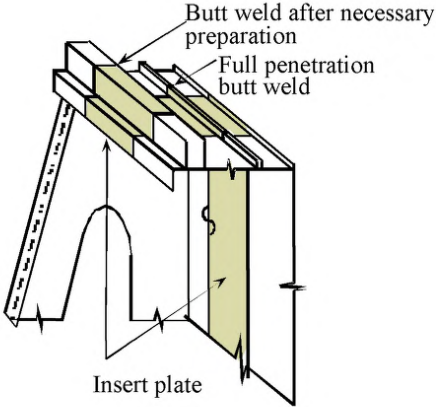
BULK CARRIERS		Guidelines for Surveys, Assessment and Repair of Hull Structure	
Part 1	Cargo hold region		Example No.
Area 1	Deck structure		11
Detail of damage		Fractures in hatch coaming top plate initiated from butt weld of compression bar	
Sketch of damage

Notes on possible cause of damage 1. Heavy weather 2. Insufficient preparation of weld of compression bar and/or rail (Although the compression bar and rail are not longitudinal strength members, they subject same longitudinal stress as longitudinal members) 3. Crack may initiate from insufficient penetration of weld of rail for hatch cover.		Notes on repairs 1. Loading condition of the ship and proper welding procedure should be carefully considered. 2. Fractured structure is to be cropped and renewed if considered necessary. (Small fracture may be vee-out and rewelded.) 3. Full penetration welding should be applied to the butt weld of compression bar and rail.

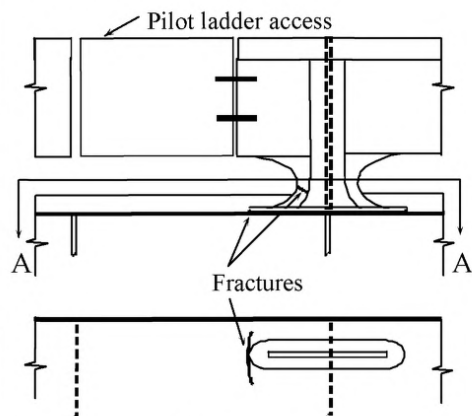
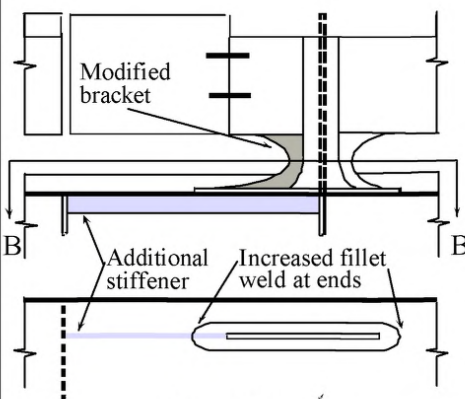
BULK CARRIERS		Guidelines for Surveys, Assessment and Repair of Hull Structure	
Part 1	Cargo hold region	Example No.	
Area 1	Deck structure	12	
Detail of damage		Fractures in deck plating at the pilot ladder access of bulwarks	
Sketch of damage

<p style="text-align: center;">View B-B</p>	
Notes on possible cause of damage 1. Stress concentration at the termination of bulwarks.		Notes on repairs 1. Fractured deck plating should be cropped and part renewed. 2. Reduction of stress concentration should be considered. In the above figure gusset plate was replaced with soft type for the fracture in gusset plate and pad plate was increased. Additional stiffeners were provided for the fracture in deck plating.

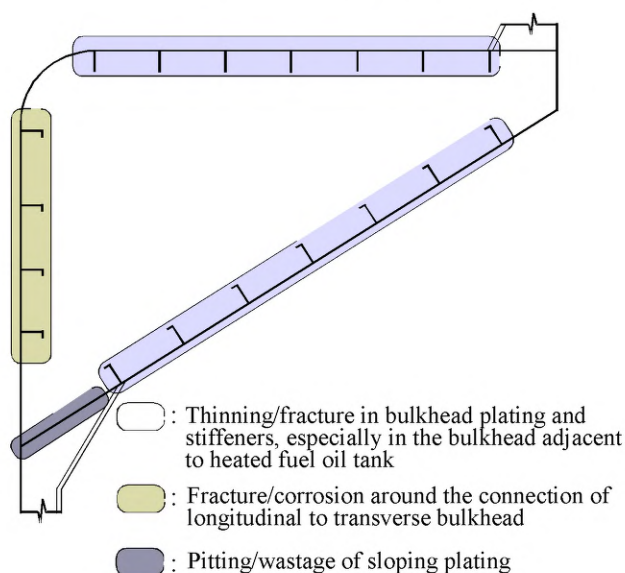
**(b) Transverse bulkhead section****Figure 1 Topside tank - Potential problem areas**

2.2.1 Deformation of structure may be caused by contact (with quay side, ice, touching underwater objects, etc.), collision, mishandling of cargo and high stress. Attention should be paid to the following areas during inspection::

- (a) Structure subjected to high stress
 - Buckling of transverse webs at corners
- (b) Structure adjacent to a ballast hold
 - Deformations may be found in the following structural members caused by sloshing in partially filled ballast hold and/or by improper carriage of ballast water (See Note):
 - Buckling of transverse web and/or collapse of transverse attached to sloping plating
 - Deformation of sloping plating and/or collapse of sloping plating longitudinals
 - Buckling of diaphragm, if provided

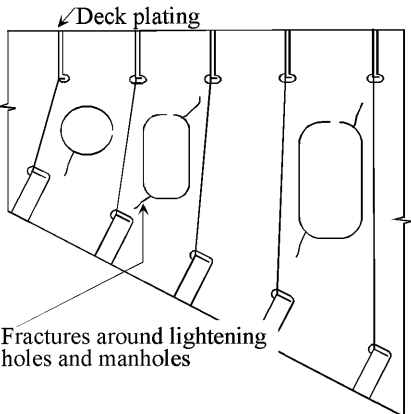
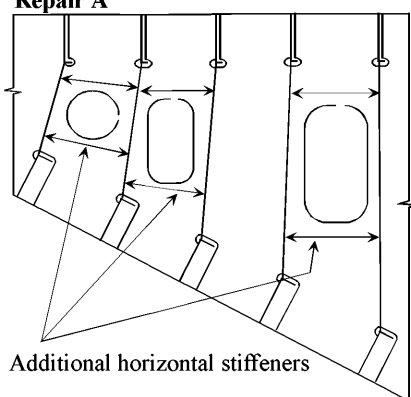
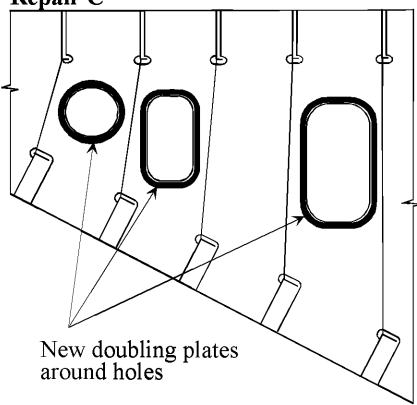
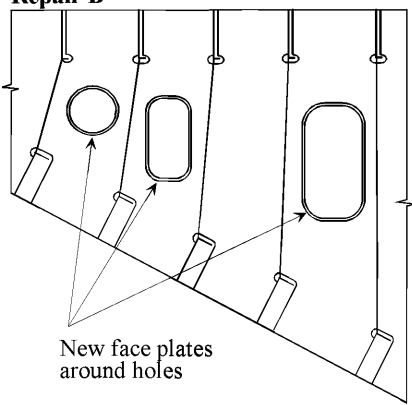
BULK CARRIERS		Guidelines for Surveys, Assessment and Repair of Hull Structure
Part 1	Cargo hold region	Example No.
Area 2	Topside tank structure	1
Detail of damage	Fractures around unstiffened lightening holes and manholes in wash bulkhead	
Sketch of damage

<p>Deck plating</p> <p>Fractures around lightening holes and manholes</p>		Sketch of repair Repair A

<p>New face plates around holes</p>
Notes on possible cause of damage 1. General levels of corrosion and presence of stress concentration.		Notes on repairs 1. Corroded/fractured plate should be cropped and renewed with plating of enhanced thickness. 2. Reinforcement should be considered.

<p>Additional horizontal stiffeners</p>
Repair C

<p>New doubling plates around holes</p>		Repair B

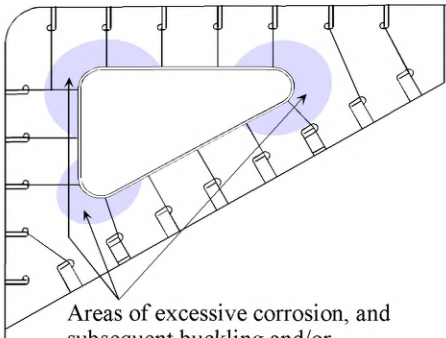
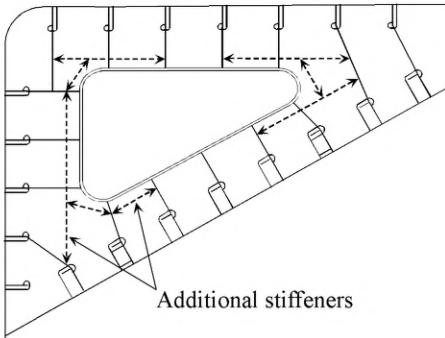
BULK CARRIERS	Guidelines for Surveys, Assessment and Repair of Hull Structure	
Part 1	Cargo hold region	Example No.
Area 2	Topside tank structure	2-a
Detail of damage	Thinning and subsequent buckling of web plating in the vicinity of the radii of the opening	
Sketch of damage

<p>Areas of excessive corrosion, and subsequent buckling and/or</p>		Sketch of repair

<p>Additional stiffeners</p>
Notes on possible cause of damage <ol style="list-style-type: none"> 1. Insufficient buckling strength. 2. Corrosion due to stress concentration at corners. 		Notes on repairs <ol style="list-style-type: none"> 1. Buckled plating is to be cropped and parts renewed, if necessary. 2. Additional stiffeners as shown above and/or renewal with plating of increased thickness should be considered.

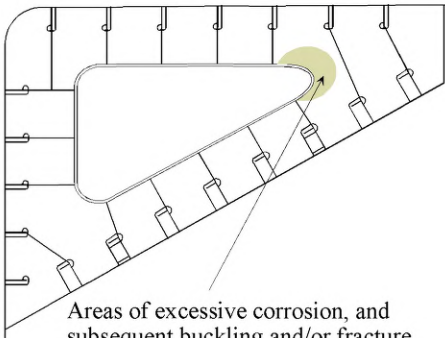
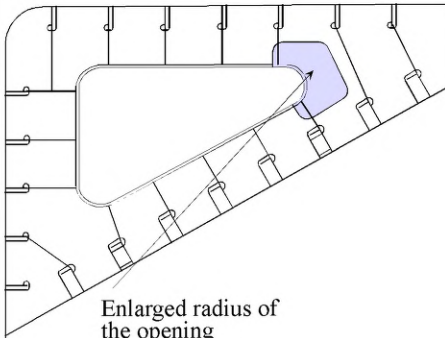
BULK CARRIERS		Guidelines for Surveys, Assessment and Repair of Hull Structure
Part 1	Cargo hold region	Example No.
Area 2	Topside tank structure	2-b
Detail of damage	Thinning and subsequent buckling of web plating in the vicinity of the radii of the opening	
Sketch of damage

<p>Areas of excessive corrosion, and subsequent buckling and/or fracture</p>		Sketch of repair

<p>Enlarged radius of the opening</p>
Notes on possible cause of damage 1. Corrosion caused by stress concentration at the corner due to insufficient radius for the opening.		Notes on repairs 1. Corroded/buckled plating is to be cropped and parts renewed with plating of increased thickness and additional stiffeners are preferable to minimize deflection. 2. An attempt should be made to improve the design of the radius if felt necessary.

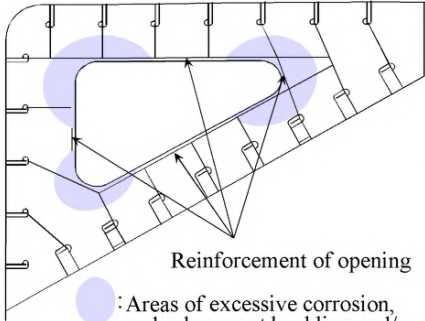
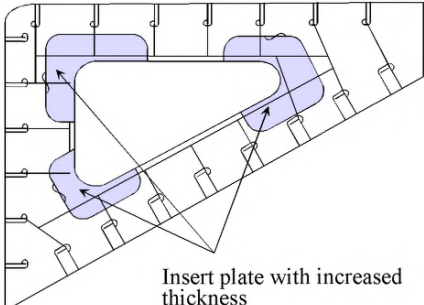
BULK CARRIERS		Guidelines for Surveys, Assessment and Repair of Hull Structure	
Part 1	Cargo hold region	Example No.	
Area 2	Topside tank structure	2-c	
Detail of damage		Thinning and subsequent buckling of web plating in the vicinity of the radii of the opening	
Sketch of damage		Sketch of repair

<p>Reinforcement of opening</p> <p>Areas of excessive corrosion, and subsequent buckling and/or</p>

<p>Insert plate with increased thickness</p>	
Notes on possible cause of damage		Notes on repairs	
1. Additional stresses at the free edge of transverse web. (In Example 2-a - 2-c face plate is provided for the reinforcement of the opening.)		1. Corroded/buckled plating is to be cropped and part renewed with plating of increased thickness.

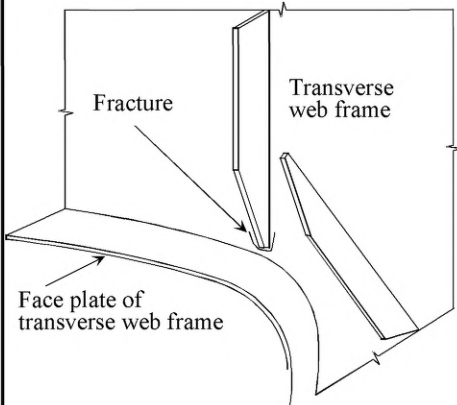
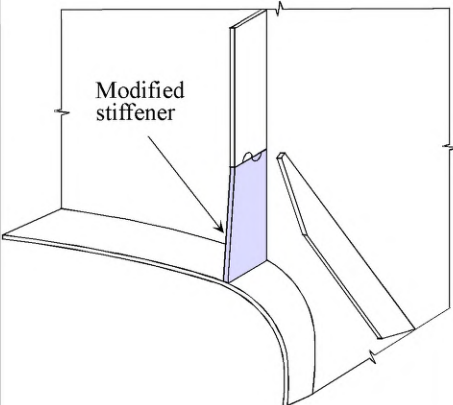
BULK CARRIERS		Guidelines for Surveys, Assessment and Repair of Hull Structure
Part 1	Cargo hold region	Example No.
Area 2	Topside tank structure	3
Detail of damage	Fractures in transverse web at sniped end of stiffener	
Sketch of damage		Sketch of repair

Notes on possible cause of damage		Notes on repairs
<ol style="list-style-type: none"> 1. Stress concentration. 		<ol style="list-style-type: none"> 1. Fracture can be veed-out and welded provided the plating is not generally corroded. If necessary, fractured plating should be cropped and renewed. 2. Excessive stress concentration at the end of stiffener should be avoided.

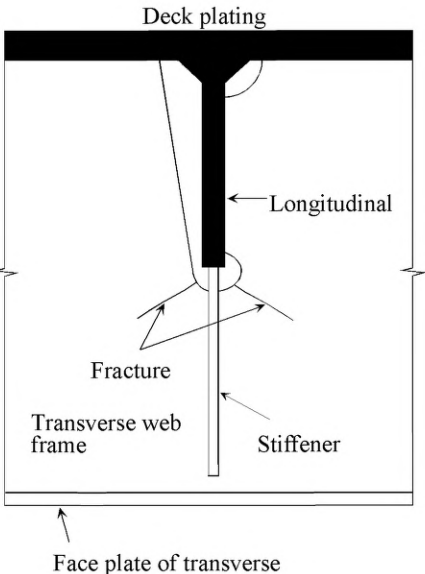
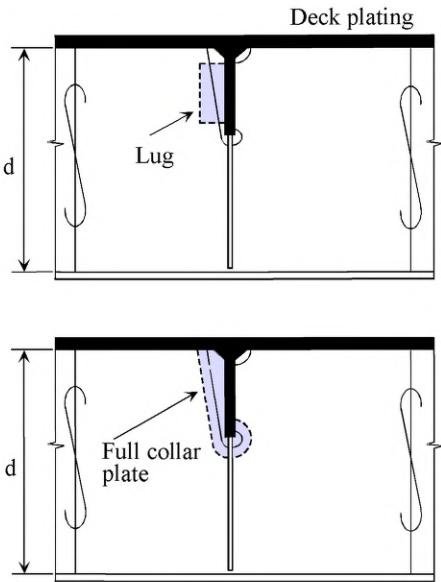
BULK CARRIERS		Guidelines for Surveys, Assessment and Repair of Hull Structure
Part 1	Cargo hold region	Example No.
Area 2	Topside tank structure	4-a
Detail of damage		Fractures at slots in way of transverse web frame
Sketch of damage		Sketch of repair

<p>(Note) Full collar plate where the depth of cut-out is more than 0.4 times the depth of web frame ($0.4d$) and in an areas of high shear stress</p>
Notes on possible cause of damage		Notes on repairs
<ol style="list-style-type: none"> 1. Damage may be created by local shear stress concentrations due to large cut-outs for notch. 2. Also deficient welds (fillet welds between deck longitudinal and stiffener). 		<ol style="list-style-type: none"> 1. Crop and part renew the web plating. 2. Close the cut-out by introducing a lug or alternatively fit a full collar plate.

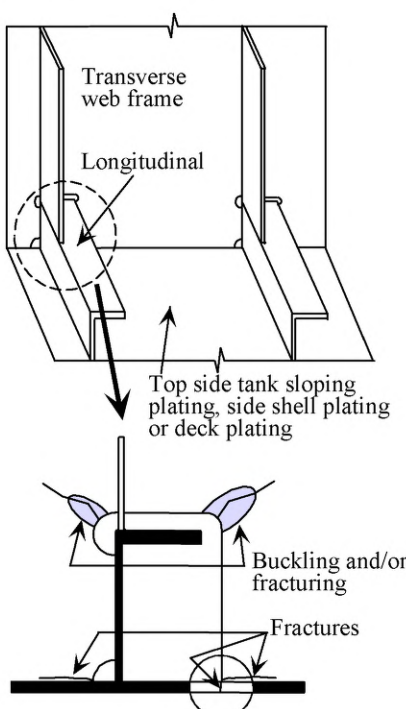
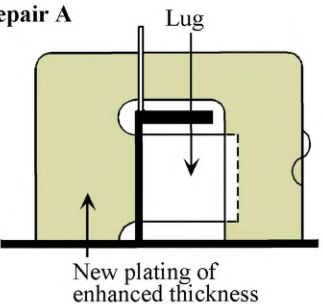
BULK CARRIERS		Guidelines for Surveys, Assessment and Repair of Hull Structure
Part 1	Cargo hold region	Example No.
Area 2	Topside tank structure	4-b
Detail of damage		Fractures and buckling at slots in way of transverse web frame
Sketch of damage

<p>Transverse web frame</p> <p>Longitudinal</p> <p>Top side tank sloping plating, side shell plating or deck plating</p> <p>Buckling and/or fracturing</p> <p>Fractures</p>		Sketch of repair <p>Repair A</p>

<p>Full collar plate</p>
Notes on possible cause of damage 1. Damage can be caused by general levels of corrosion and presence of stress concentration associated with the presence of a cut-out.		Notes on repairs 1. If fractures are significant then crop and part renew the plating otherwise the fracture can be veed-out and welded provided the plating is not generally corroded. 2. Repair A Lug should be considered. 3. Repair B Full collar plate should be considered where the depth of cut-out is more than 0.4 times the depth of web frame and in an area of high shear stress or the existing lug proves to be ineffective.

<p>Lug</p> <p>New plating of enhanced thickness</p> <p>Repair B</p>

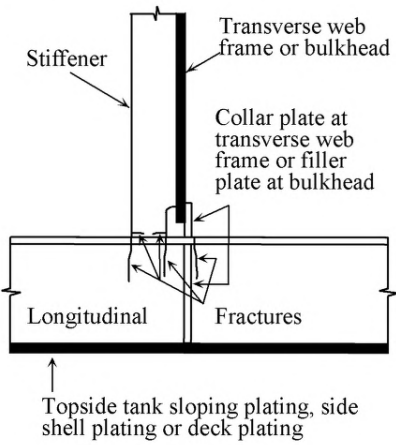
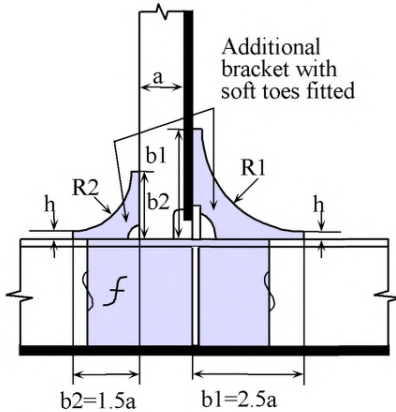
BULK CARRIERS		Guidelines for Surveys, Assessment and Repair of Hull Structure
Part 1	Cargo hold region	Example No.
Area 2	Topside tank structure	5
Detail of damage		Fractures in longitudinal at transverse web frame or bulkhead
Sketch of damage

<p>Stiffener</p> <p>Transverse web frame or bulkhead</p> <p>Collar plate at transverse web frame or filler plate at bulkhead</p> <p>Longitudinal</p> <p>Fractures</p> <p>Topside tank sloping plating, side shell plating or deck plating</p>		Sketch of repair

Notes on possible cause of damage <ol style="list-style-type: none"> 1. Damage can be caused by stress concentrations leading to accelerated fatigue in this region. 		Notes on repairs <ol style="list-style-type: none"> 1. If fracture extends to over one third of the depth of the longitudinal, then crop and part renew. Otherwise the fracture can be veed-out and welded.

<p>Additional bracket with soft toes fitted</p> <p>a</p> <p>$b1$</p> <p>$b2$</p> <p>$R1$</p> <p>$R2$</p> <p>h</p> <p>f</p> <p>$b2=1.5a$</p> <p>$b1=2.5a$</p> <p>f: Where required, the longitudinal to be cropped and part renewed</p> <ol style="list-style-type: none"> 1. For a slope at toes max. 1:3, $R1=(b1-h) \times 1.6$ and $R2=(b2-h) \times 1.6$ 2. Soft toe bracket to be welded first to longitudinal 3. Scallop in bracket to be as small as possible, recommended max. 35mm 4. If toes of brackets are ground smooth, full penetration welds in way to be provided 5. Maximum length to thickness ratio =50:1 for unstiffened bracket edge 6. Toe height, h, to be as small as possible (10-15mm)

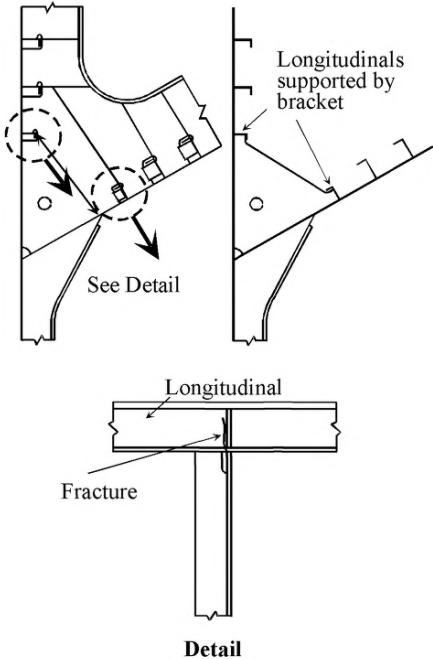
BULK CARRIERS		Guidelines for Surveys, Assessment and Repair of Hull Structure
Part 1	Cargo hold region	Example No.
Area 2	Topside tank structure	6
Detail of damage Fractures in the lowest longitudinal at transverse web frame		
Sketch of damage

<p>Longitudinals supported by bracket</p> <p>See Detail</p> <p>Longitudinal</p> <p>Fracture</p> <p>Detail</p>

<p>Increased bracket</p>
Notes on possible cause of damage		Notes on repairs
<ol style="list-style-type: none"> 1. Insufficient scantling for torsional rigidity (The lowest longitudinal is usually supported by bracket(s) as shown in the above and smaller scantling may be adopted. However, the lowest longitudinal undergoes torsion from side shell frame through bracket(s) and may suffer fracture.) 		<ol style="list-style-type: none"> 1. Fractured part to be cropped and renewed. 2. Size of bracket should be increased

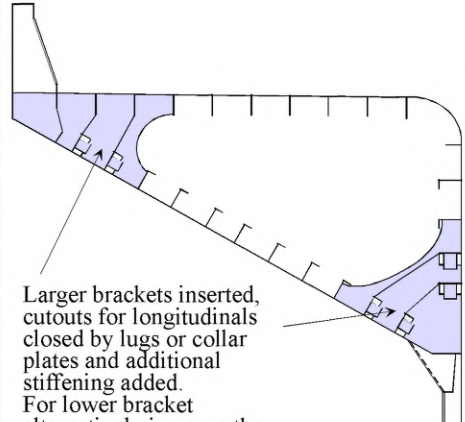
BULK CARRIERS		Guidelines for Surveys, Assessment and Repair of Hull Structure
Part 1	Cargo hold region	Example No.
Area 2	Topside tank structure	7-a
Detail of damage		Fractures in transverse brackets
Sketch of damage

<p>Fractures in the transverse brackets</p>		Sketch of repair

<p>Larger brackets inserted, cutouts for longitudinals closed by lugs or collar plates and additional stiffening added. For lower bracket alternatively increase the thickness</p>
Notes on possible cause of damage <ol style="list-style-type: none"> 1. General levels of corrosion and presence of stress concentrations. 2. Misalignment of the brackets with adjoining structure, e.g. side shell frame brackets and/or coaming brackets. 3. High shear stresses due to insufficient bracket size. 4. Inadvertent overloading. 		Notes on repairs <ol style="list-style-type: none"> 1. If the damage is caused by misalignment with the side shell frame brackets or the hatch coaming brackets the misalignment is to be rectified and the replacement by larger brackets incorporated only if considered necessary.

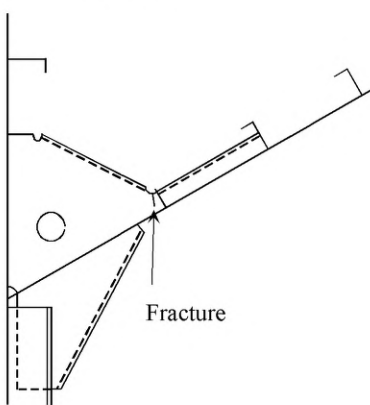
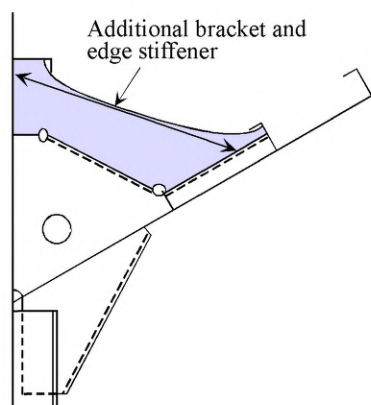
BULK CARRIERS		Guidelines for Surveys, Assessment and Repair of Hull Structure	
Part 1	Cargo hold region	Example No.	
Area 2	Topside tank structure	7-c	
Detail of damage		Fractures at toes of transverse bracket	
Sketch of damage		Sketch of repair

Notes on possible cause of damage		Notes on repairs	
1. Stress concentration due to the shape of the bracket.		1. Cracked weld to be veed-out and rewelded.

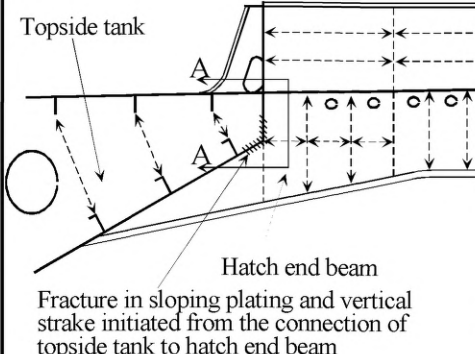
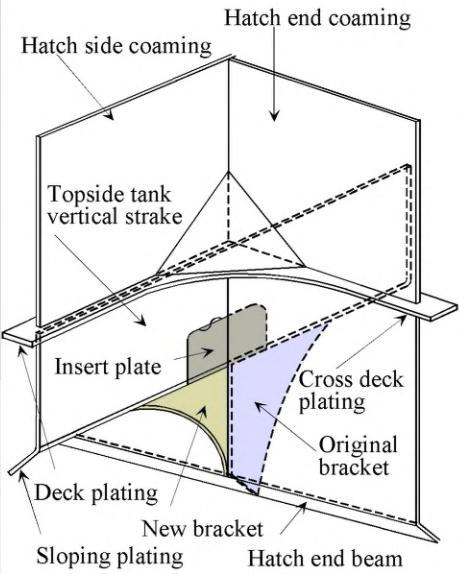
BULK CARRIERS		Guidelines for Surveys, Assessment and Repair of Hull Structure
Part 1	Cargo hold region	Example No.
Area 2	Topside tank structure	8
Detail of damage	Fractures in sloping plating and vertical strake initiated from the connection of topside tank to hatch end beam	
Sketch of damage

<p>Topside tank</p> <p>Hatch end beam</p> <p>Fracture in sloping plating and vertical strake initiated from the connection of topside tank to hatch end beam</p> <p>Topside tank vertical strake</p> <p>Deck plating</p> <p>Fracture</p> <p>Hatch end beam</p> <p>Topside tank knuckle line</p> <p>Original bracket (See "Sketch of repair")</p> <p>View A-A</p>		Sketch of repair

Notes on possible cause of damage 1. Stress concentration at the connection of hatch end beam to topside tank.		Notes on repairs 1. Fractured part to be cropped and renewed with increased thickness. 2. Additional bracket should be considered for reinforcement.

<p>Hatch end coaming</p> <p>Hatch side coaming</p> <p>Topside tank vertical strake</p> <p>Insert plate</p> <p>Cross deck plating</p> <p>Original bracket</p> <p>Deck plating</p> <p>New bracket</p> <p>Sloping plating</p> <p>Hatch end beam</p>

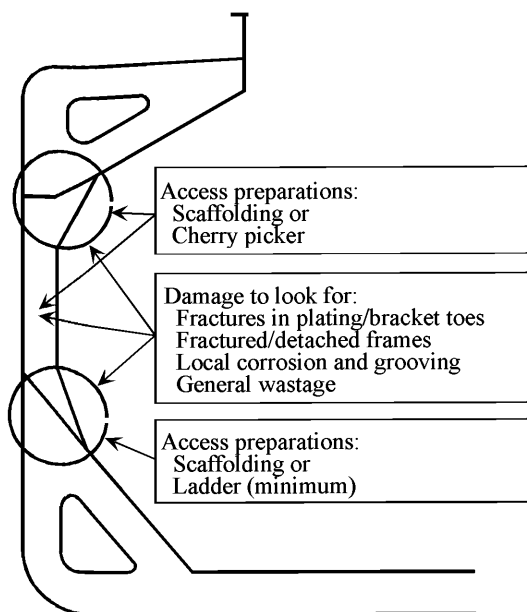
Figure 1
Side shell frame - Potential problem areas

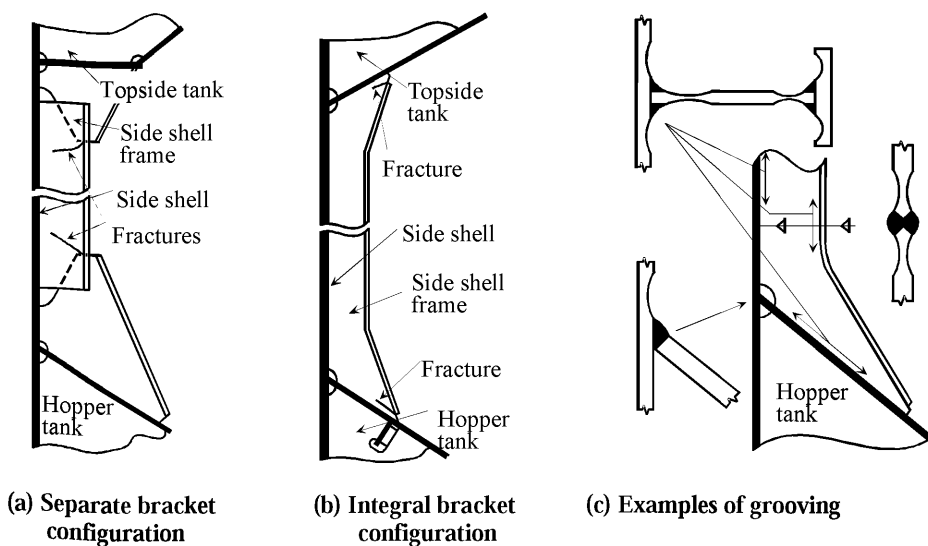
Figure 2 Damages to side shell frame - Potential problem areas

(Note) The type of bracket configuration used will, to a large extent, dictate the location and extent of fracture. Where separate brackets are employed, the fracture location is normally at the bracket toe position on the frames, whereas with integral brackets the location is at the toe position on the hopper and topside tank.

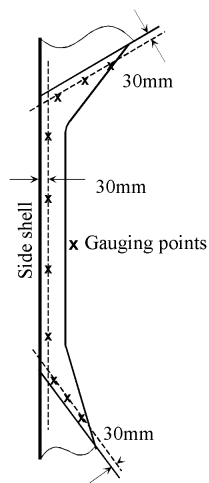
Figure 3
Representative gauging locations on the side shell frame - Potential problem areas

2.1.2 It is not unusual to find highly localised corrosion on uncoated side shell frames and their end connections. The loss in the thickness is normally greater close to the side shell plating rather than near the faceplate, and consequently representative thickness measurements should be in that area (See **Figure 3**). This situation, if not remedied, can result in loss of support to the shell plating and hence large inboard deflections. In many cases such deflections of the side shell plating can generate fractures in the shell plating and fracturing and buckling of the frame web plates and eventually result in detachment of the end brackets from the hopper tank.

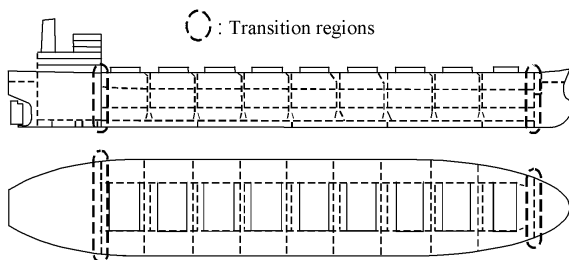
- 1.5 The structure at the transition regions at the fore and aft ends of the ship are subject to stress concentrations due to structural discontinuities. The side shell plating at the transition regions is also subject to panting. The lack of continuity of the longitudinal structure, and the increased slenderness and flexibility of the side structure, makes the structure at the transition regions more prone to fracture damages.

Figure 4 Transition regions - Potential problem area

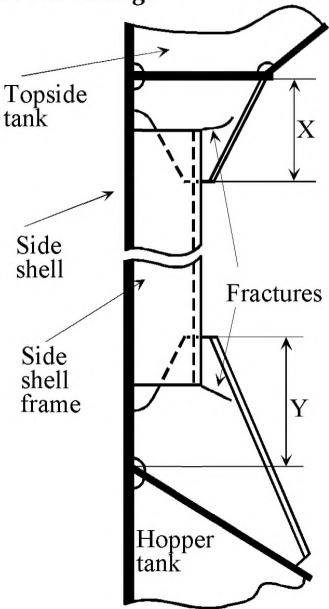
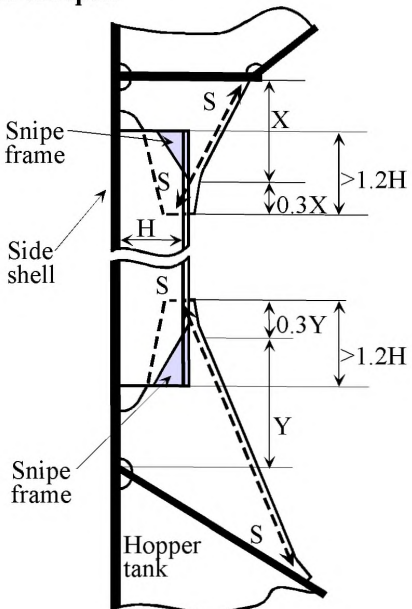
BULK CARRIERS		Guidelines for Surveys, Assessment and Repair of Hull Structure	
Part 1	Cargo hold region		Example No.
Area 3	Cargo hold side structure		1-a
Detail of damage		Fractures in brackets at termination of frame	
Sketch of damage		Sketch of repair

<p>Separate bracket configuration</p>

<p>S=Snipped end</p>	
Notes on possible cause of damage		Notes on repairs	
<ol style="list-style-type: none"> 1. This type of damage is caused due to stress concentration. 		<ol style="list-style-type: none"> 1. For small fractures, e. g. hairline fractures, the fracture can be veed-out, ground, examined by NDT for fractures, and rewelded. 2. For larger/significant fractures consideration is to be given to cropping and partly renewing/ renewing the frame brackets. If renewing the brackets, end of frames can be sniped to soften them. 3. If felt prudent, soft toes are to be incorporated at the boundaries of the bracket to the hopper plating. 4. Attention to be given to the structure in wing tanks in way of the extended bracket arm. i.e. reinforcement provided in line with the bracket.

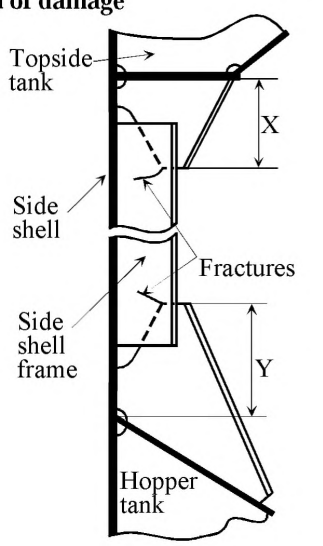
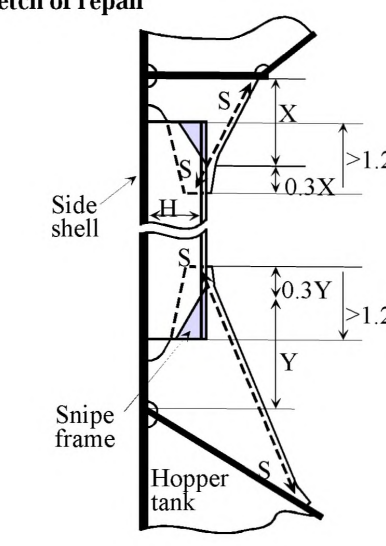
BULK CARRIERS		Guidelines for Surveys, Assessment and Repair of Hull Structure
Part 1	Cargo hold region	Example No.
Area 3	Cargo hold side structure	1-b
Detail of damage	Fractures in side shell frame at bracket's toe	
Sketch of damage

Separate bracket configuration		Sketch of repair

S=Snipped end
Notes on possible cause of damage 1. This type of damage is caused due to stress concentration.		Notes on repairs 1. For small fractures, e. g. hairline fractures, the fracture can be veed-out, welded up, ground, examined by NDT for fractures, and rewelded. 2. For larger/significant fractures consideration is to be given to cropping and partly renewing/ renewing the frame brackets. If renewing the brackets, end of frames can be sniped to soften them. 3. If felt prudent, soft toes are to be incorporated at the boundaries of the bracket to the hopper plating. 4. Attention to be given to the structure in wing tanks in way of the extended bracket arm. i.e. reinforcement provided in line with the bracket.

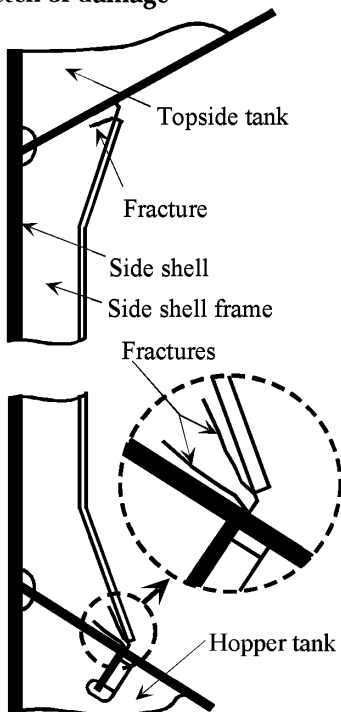
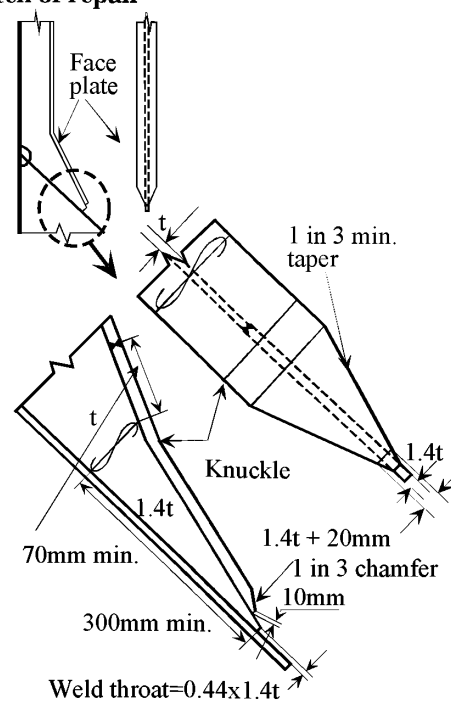
BULK CARRIERS		Guidelines for Surveys, Assessment and Repair of Hull Structure	
Part 1	Cargo hold region	Example No.	
Area 3	Cargo hold side structure	2	
Detail of damage	Fractures in side shell frame at bracket's toe		
Sketch of damage		Sketch of repair

1. This type of damage is caused due to stress concentration.		1. Repair is to incorporate a design similar to the one shown on the sketch and in addition:- 1.1. The arm of the bracket along the hopper/ topside plating should be increased by altering the angle of the bracket face plate. A face plate taper of 1 in 3 should be arranged. 1.2. The local thickness of the bracket web plating over the length of the new face plate taper should be increased by about 40% above that originally fitted. 1.3. The face plate thickness should be chamfered 1 in 3 to a thickness at its extremity. 1.4. Welding of the new bracket toe should be based on a weld factor of 0.44 applied to the increased thickness. 2. Attention to be given to the structure in wing tanks in way of the extended bracket arm. i.e. reinforcement provided in line with the bracket.

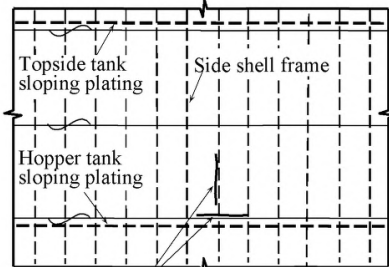
BULK CARRIERS		Guidelines for Surveys, Assessment and Repair of Hull Structure
Part 1	Cargo hold region	Example No.
Area 3	Cargo hold side structure	3
Detail of damage	Fractures in side shell frame/lower bracket and side shell plating near hopper	
Sketch of damage

<p>Topside tank sloping plating</p> <p>Side shell frame</p> <p>Hopper tank sloping plating</p> <p>Fracture in side shell plating along side shell frame and hopper tank sloping plating</p>		Sketch of repair

<p>Part renewal including side shell frames and hopper sloping plating, as found necessary</p>
Notes on possible cause of damage 1. Heavy corrosion (grooving). Refer to Figure 2 (c) .		Notes on repairs 1. Sketch of repair applies when damage extends over several frames. 2. Isolated fractures may be repaired by veeing-out and rewelding. 3. Isolated cases of grooving may be repaired by build up of welding.

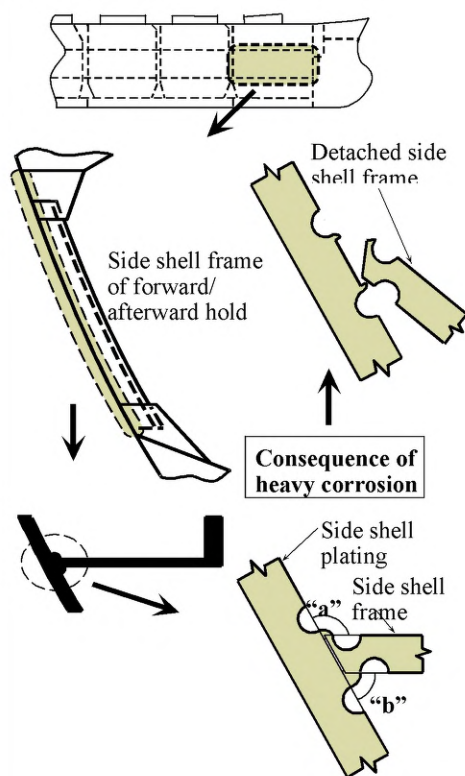
BULK CARRIERS		Guidelines for Surveys, Assessment and Repair of Hull Structure	
Part 1	Cargo hold region	Example No.	
Area 3	Cargo hold side structure	5	
Detail of damage		Adverse effect of corrosion on the frame of forward/afterward hold	
Sketch of damage		Sketch of repair

<p>Side shell frame of forward/afterward hold</p> <p>Detached side shell frame</p> <p>Consequence of heavy corrosion</p> <p>Side shell plating</p> <p>Side shell frame "a" frame</p> <p>"b"</p>

<ol style="list-style-type: none"> 1. Part renewal including side shell frames and hopper plating, as found necessary 2. Deep penetration welding at the connections of side shell frames to side shell plating 	
Notes on possible cause of damage <ol style="list-style-type: none"> 1. Heavy corrosion (grooving) of side shell frame along side shell plating and difference of throat thickness "a" from "b". (Since original throat thickness of "a" is usually smaller than that of "b", if same welding procedure is applied, the same corrosion has a more severe effect on "a", and may cause collapse and/or detachment of side shell frame.) 		Notes on repairs <ol style="list-style-type: none"> 1. Sketch of repair applies when damage extends over several frames. 2. Isolated fractures may be repaired by veeing-out and rewelding. 3. Isolated cases of grooving may be repaired by build up of welding.

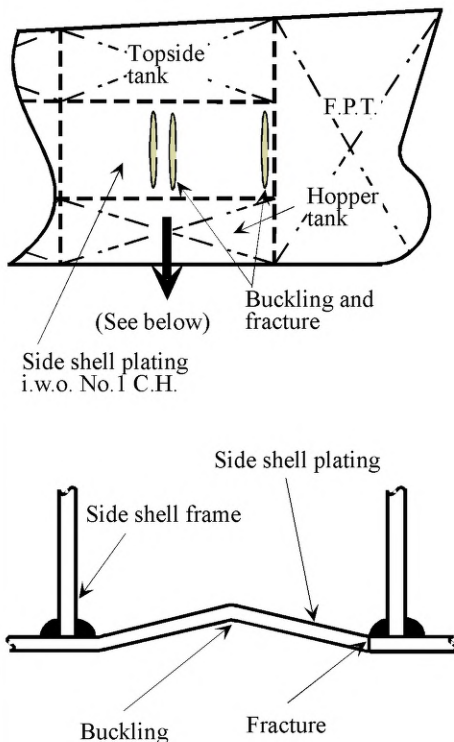
BULK CARRIERS		Guidelines for Surveys, Assessment and Repair of Hull Structure
Part 1	Cargo hold region	Example No.
Area 3	Cargo hold side structure	6
Detail of damage		Buckling and fractures of side shell plating in foremost cargo hold
<p>Sketch of damage</p>

<p>View A-A</p>
<p>Notes on possible cause of damage</p> <ol style="list-style-type: none"> 1. Heavy weather. 2. Insufficient buckling strength due to high tensile steel or heavy uniform corrosion. 3. Inadequate transition structure. 		<p>Notes on repairs</p> <ol style="list-style-type: none"> 1. Buckled/fractured side shell plating is to be cropped and renewed. 2. Reinforcement by thicker side shell plating and/or additional stiffeners should be considered.

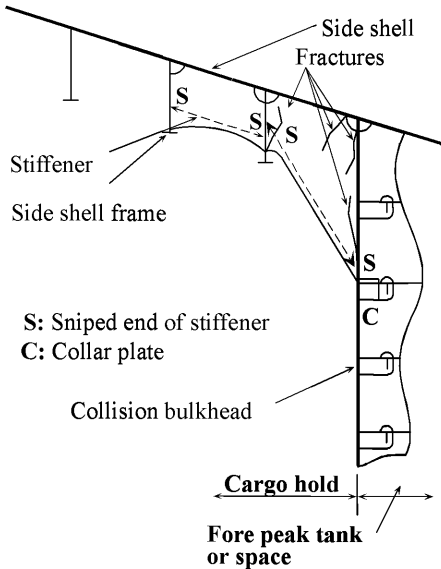
BULK CARRIERS		Guidelines for Surveys, Assessment and Repair of Hull Structure
Part 1	Cargo hold region	Example No.
Area 3	Cargo hold side structure	7
Detail of damage		Fractures at the supporting brackets in way of the collision bulkhead
Sketch of damage

<p>Side shell</p> <p>Fractures</p> <p>Stiffener</p> <p>Side shell frame</p> <p>S: Sniped end of stiffener</p> <p>C: Collar plate</p> <p>Collision bulkhead</p> <p>Cargo hold</p> <p>Fore peak tank or space</p>		Sketch of repair

<p>Modified bracket</p> <p>Stiffener</p> <p>S: Sniped end of stiffener</p> <p>C: Collar plate</p> <p>Collision bulkhead</p> <p>Cargo hold</p> <p>Fore peak tank or space</p>
Notes on possible cause of damage <ol style="list-style-type: none"> 1. Insufficient bracket size resulting in high stress due to load cantilevered from side frame. 2. Stress concentration at toe of bracket and misalignment between bracket and stringer in fore peak tank or space. 		Notes on repairs <ol style="list-style-type: none"> 1. The extended bracket arm connection to the collision bulkhead is to have a soft toe, and any cut-outs for stiffeners in the fore peak tank or space are to be collared when situated in the vicinity of the bracket toe. 2. When fractures have extended into the side shell or bulkhead plating, the plating is to be cropped and part renewed.
