No.76 IACS Guidelines for Surveys, Assessment and Repair of Hull Structure – Bulk Carriers

(1994)
(Rev.1
July 2001)
(Rev.2
June 2004)
(Corr.1
Sept 2007)

BULK CARRIERS

Guidelines for Surveys, Assessment and Repair of Hull
Structure

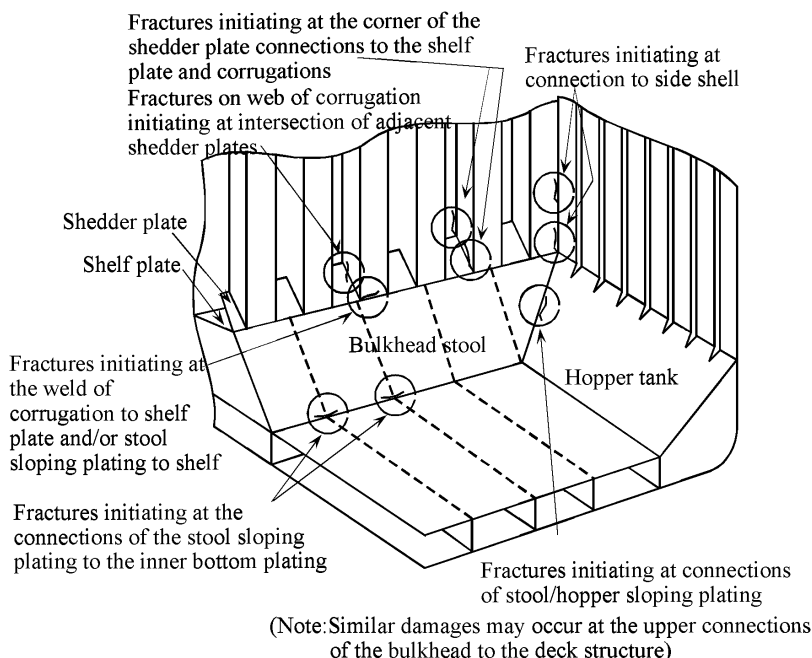
Figure 2 Typical fracturing at the connection of transverse bulkhead structure

2.3.1 Fractures usually occur at the boundaries of corrugations and bulkhead stools particularly in way of shelf plates, shedder plates, deck, inner bottom, etc. (See **Figure 2**).

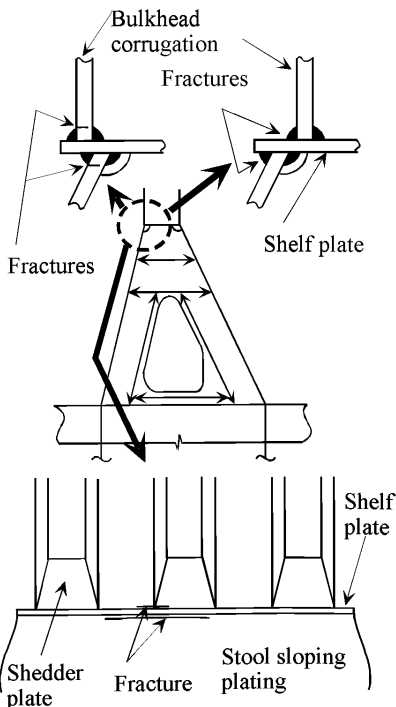
BULK CARRIERS		Guidelines for Surveys, Assessment and Repair of Hull Structure
Part 1	Cargo hold region	Example No.
Area 4	Transverse bulkhead and associated structure in cargo hold	1-b
Detail of damage Fractures at weld connections to stool shelf plate		
Sketch of damage		Sketch of repair

Notes on possible cause of damage		Notes on repairs
<ol style="list-style-type: none"> 1. Misalignment between corrugation flange and sloping stool plating. 2. Inadequate welding area connecting corrugation flange to shelf plate or similarly sloping stool plating to shelf plate. 		<ol style="list-style-type: none"> 1. Fractures to be veed-out and rewelded. 2. Structure to be released and misalignment rectified. 3. Edge of the corrugated bulkhead and the stool plating on both sides of shelf plate to have full penetration welds. 4. Where necessary an insert plate to be arranged in stool plating.

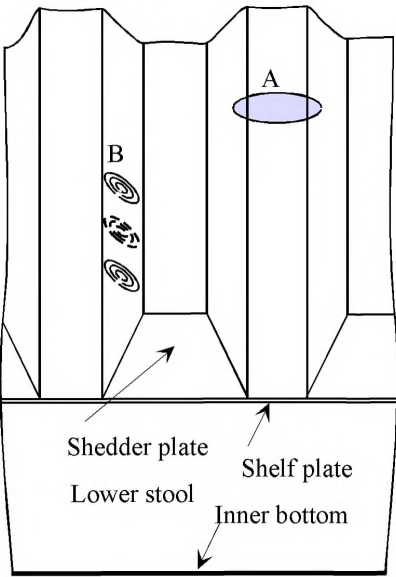
BULK CARRIERS		Guidelines for Surveys, Assessment and Repair of Hull Structure
Part 1	Cargo hold region	Example No.
Area 4	Transverse bulkhead and associated structure in cargo hold	3
Detail of damage		Indentation and buckling of vertical corrugation
Sketch of damage		Sketch of repair

<p>Plating part</p>
Notes on possible cause of damage		Notes on repairs
<ol style="list-style-type: none"> 1. Damages by mechanical abuse during cargo handling e.g. grab damage. 2. Damage resulting from thickness reduction by corrosion. 3. Buckling caused by bending or shear, see locations A and B respectively above, with a minimum reduction in thickness could be caused by underdesign or overloading. If this cause is suspected, the Classification Society concerned shall be contacted before proceeding with repairs. 		<ol style="list-style-type: none"> 1. Damage by mechanical abuse If the indentation/buckling is local and of a minor nature, the plating can be faired in place. If the deformation is more pronounced and/or in association with a generalized reduction in thickness the plating is to be cropped and renewed, as shown at locations A and B above. 2. Damage resulting from corrosion In this case thickness measurements are to be taken at mid-span and top and bottom of corrugations, and corrugations renewed or part renewed as necessary. Particular attention is to be given to the fit and alignment at corners of flanged corrugations when being partly renewed.

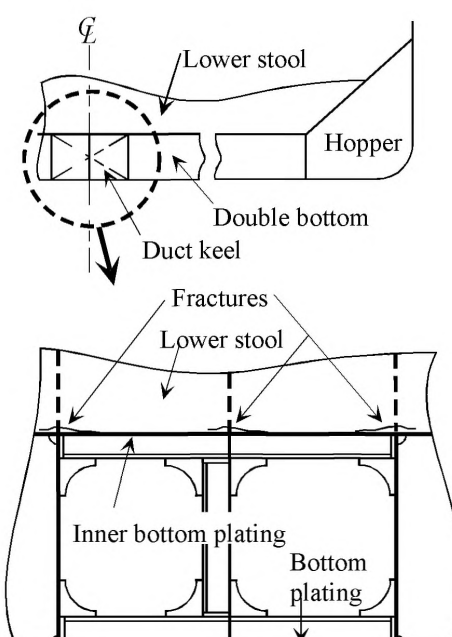
BULK CARRIERS		Guidelines for Surveys, Assessment and Repair of Hull Structure
Part 1	Cargo hold region	Example No.
Area 4	Transverse bulkhead and associated structure in cargo hold	5
Detail of damage	Fractures at weld connection of lower stool plating to inner bottom in way of duct keel	
Sketch of damage		Sketch of repair

<p>Lower stool: Insert plate of increased</p> <p>Inner bottom plating: It may be necessary to crop and insert plating of enhanced grade</p> <p>Plate collar</p> <p>Increased depth of stiffener to suit arrangement of pipes in duct keel</p> <p>Full penetration welds</p> <p>Lower stool space</p> <p>Plate collars</p> <p>Fillet weld of DB OT/WT girder to be made full penetration over length of stool space</p> <p>View A - A</p>
Notes on possible cause of damage		Notes on repairs
<ol style="list-style-type: none"> 1. This type of failure is more likely to occur at the boundaries of the ballast hold. 2. The fractures arise because of stress concentration in way of cut-outs and exacerbated by the flexibility of the inner bottom structure in way of the duct keel. 		<ol style="list-style-type: none"> 1. In order to prevent recurrence of the damage, the additional reinforcement shown should be fitted.

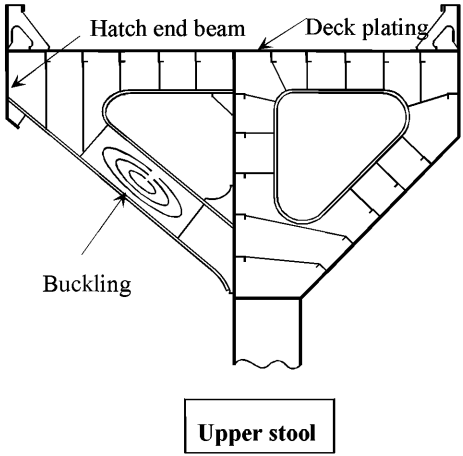
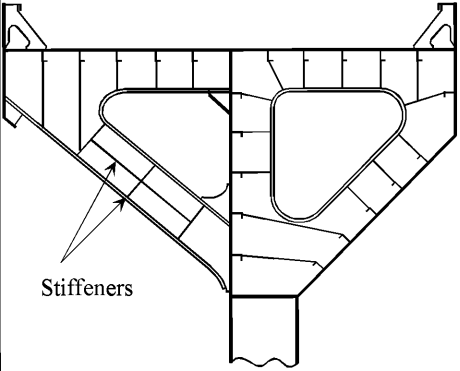
BULK CARRIERS		Guidelines for Surveys, Assessment and Repair of Hull Structure
Part 1	Cargo hold region	Example No.
Area 4	Transverse bulkhead and associated structure in cargo hold	7
Detail of damage		Buckling of strut supporting hatch end beam
Sketch of damage		Sketch of repair

Notes on possible cause of damage <ol style="list-style-type: none"> 1. Insufficient strength 2. Partial ballast loading in ballast cargo hold (sloshing) 3. Corrosion 		Notes on repairs <ol style="list-style-type: none"> 1. Deformed part to be cropped and renewed if considered necessary. 2. If the damage occurred due to insufficient strength, appropriate reinforcement is to be considered (thicker plate/additional stiffener(s)).

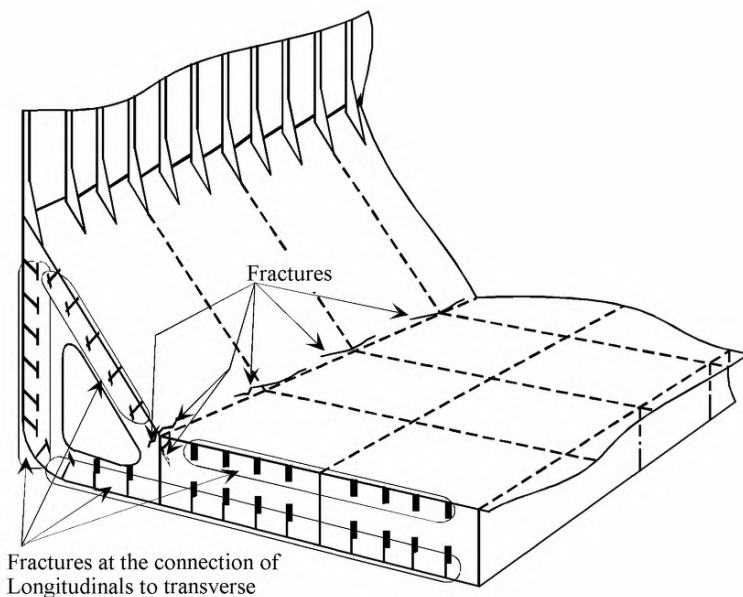
Figure 1 Typical fractures in the connection of hopper sloping plating to inner bottom (tank top) and longitudinals to transverse (or transverse bulkhead)

- 2.3.1** Fractures will normally be found by close-up inspection. Fractures that

extend through the thickness of the plating or through the welds may be observed during pressure testing of the double bottom tanks (See **Figure 1** and **2** of **Area 4**).

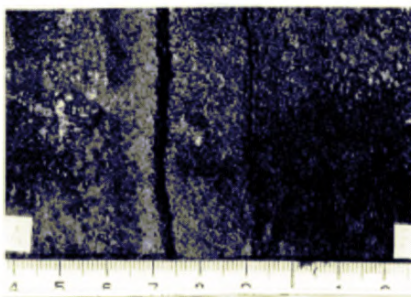
Photograph 1
Grooving corrosion of welding of bottom plating

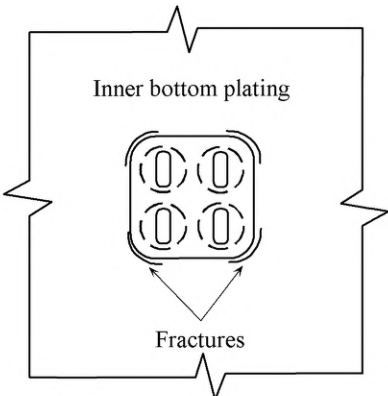
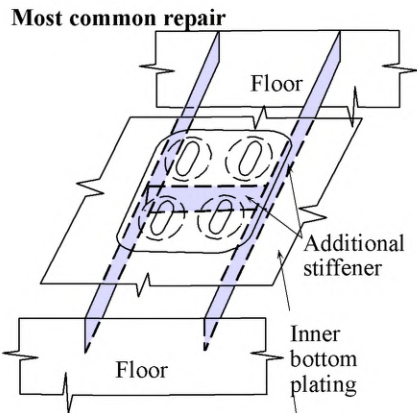
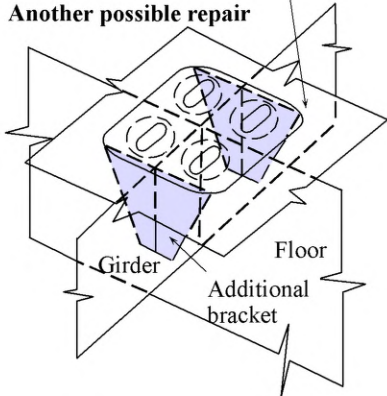
BULK CARRIERS	Guidelines for Surveys, Assessment and Repair of Hull Structure	
Part 1	Cargo hold region	Example No.
Area 5	Double bottom structure including hopper	1
Detail of damage	Fractures in inner bottom plating around container bottom pocket	
Sketch of damage	<div style="display: flex; justify-content: space-around;"> <div style="width: 45%;">

<p>Inner bottom plating</p> <p>Fractures</p> </div> <div style="width: 45%;"> <p>Sketch of repair</p> <p>Most common repair</p>

<p>Girder</p> <p>Floor</p> <p>Additional bracket</p> </div> </div>	
Notes on possible cause of damage	Notes on repairs <ol style="list-style-type: none"> 1. Pocket is not supported correctly by floor, longitudinal and/or stiffener. 1. Fractured plating should be cropped and part renewed. 2. Adequate reinforcement should be considered.

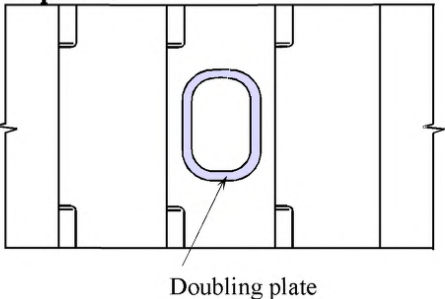
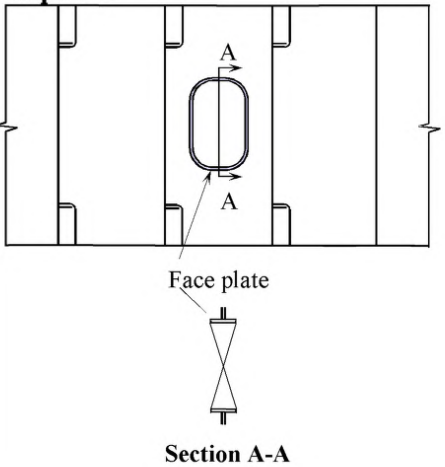
BULK CARRIERS		Guidelines for Surveys, Assessment and Repair of Hull Structure	
Part 1	Cargo hold region	Example No.	
Area 5	Double bottom structure including hopper	2	
Detail of damage		Fractures, corrosion and/or buckling of floor/girder around lightening hole	
Sketch of damage

Notes on possible cause of damage <ol style="list-style-type: none"> 1. Insufficient strength due to lightening hole. 2. Fracture, corrosion and/or buckling around lightening hole due to high stress. 		Notes on repairs <ol style="list-style-type: none"> 1. Fractured, corroded and/or buckled plating should be cropped and renewed if considered necessary. 2. Appropriate reinforcement should be considered.

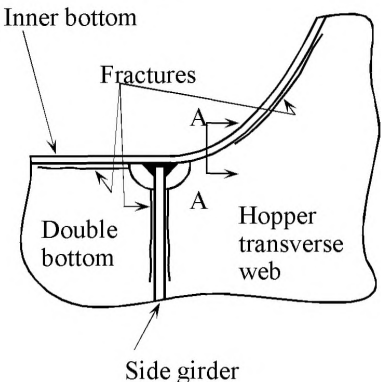
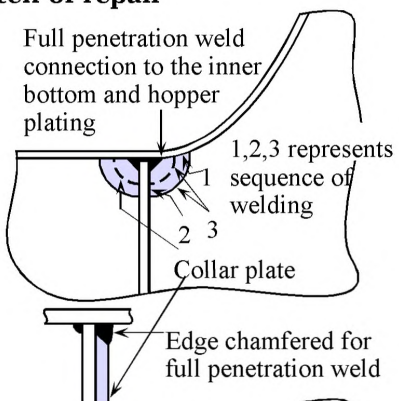
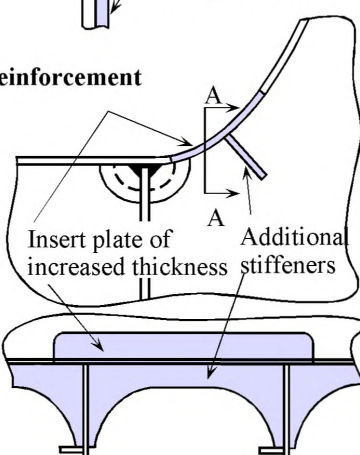
BULK CARRIERS		Guidelines for Surveys, Assessment and Repair of Hull Structure
Part 1	Cargo hold region	Example No.
Area 5	Double bottom tank structure including hopper	3
Detail of damage	Fractures at weld connections of floors in way of hopper/inner bottom interface (radiused knuckle)	
Sketch of damage

View A - A Transverse fractures in hopper web plating into possibly extending into the hopper sloping plating

Notes on possible cause of damage 1. The damage is partly due to stress concentrations at the edges of the weld created by the presence of cut-outs and local stress variations caused by the deflections in the inner bottom/hopper plating.		Notes on repairs 1. The fracture in the weld and/or plating is veed-out/cropped and renewed as appropriate. 2. The cut-outs are eliminated by introducing suitable collar plate with emphasis on edge preparation and sequence of welding as shown above. 3. Further reinforcements may need to be carried out as shown above, however, after consultation with the Classification Society concerned.

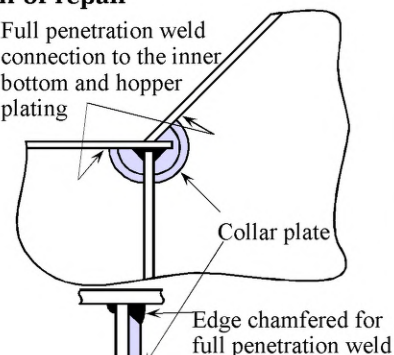
BULK CARRIERS		Guidelines for Surveys, Assessment and Repair of Hull Structure
Part 1	Cargo hold region	Example No.
Area 5	Double bottom tank structure including hopper	4
Detail of damage		Fractures at weld connections of floors in way of hopper/inner bottom interface (welded knuckle)
Sketch of damage

View A - A Transverse fractures in hopper web plating into possibly extending into the hopper sloping plating		Sketch of repair

Reinforcement A Alternatively, may stop at longitudinals where fitted
Notes on possible cause of damage 1. The damage is partly due to stress concentration at the edges of the weld created by the presence of the deflections in the inner bottom/hopper plating.		Notes on repairs 1. The fracture in the weld and/or plating is veed-out/cropped and renewed as appropriate. 2. The cut-outs are eliminated by introducing suitable collar plates with emphasis on edge preparation and sequence of welding as shown above. 3. Further reinforcements may be incorporated as shown above and depending on the judged cause of damage.

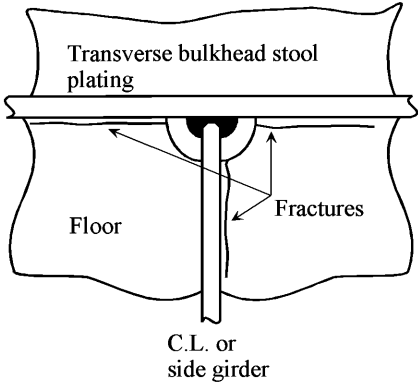
BULK CARRIERS		Guidelines for Surveys, Assessment and Repair of Hull Structure
Part 1	Cargo hold region	Example No.
Area 5	Double bottom tank structure including hopper	5
Detail of damage	Fractures at weld connections of floors in way of inner bottom and side girders, and plating of bulkhead stool	
Sketch of damage

Notes on possible cause of damage 1. Stress concentration at the welds due to scallops.		Notes on repairs 1. The scallops will require to be fitted with welded collar plates to reduce stresses in the area.

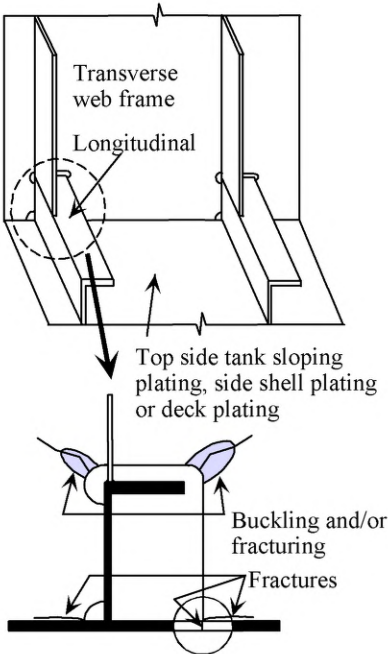
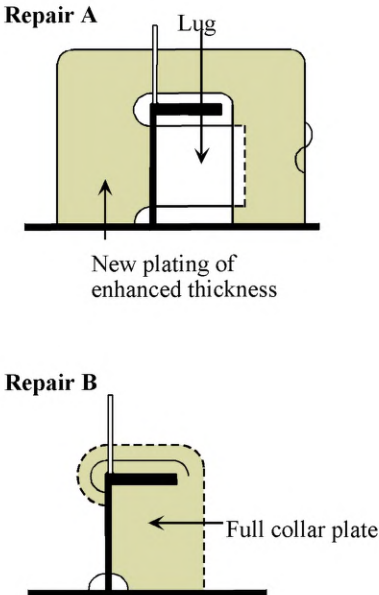
BULK CARRIERS		Guidelines for Surveys, Assessment and Repair of Hull Structure
Part 1	Cargo hold region	Example No.
Area 5	Double bottom tank structure including hopper	6
Detail of damage	Fractures and buckling in way of a cut-out for the passage of a longitudinal through a transverse primary member	
Sketch of damage

Notes on possible cause of damage 1. Damage can be caused by general levels of corrosion and presence of stress concentration associated with the presence of a cut-out.		Notes on repairs 1. If fractures are significant then crop and part renew the floor plating/transverse web otherwise the fracture can be vee-d out and welded provided the plating is not generally corroded. 2. Repair B is to be incorporated if the lug proves to be ineffective.

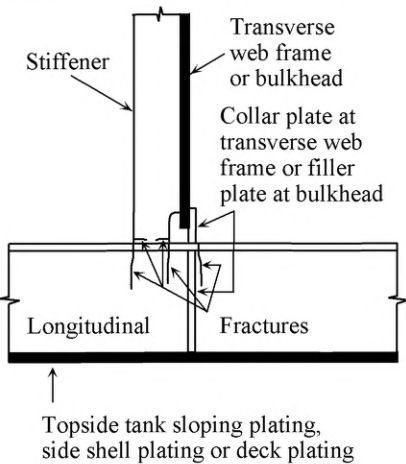
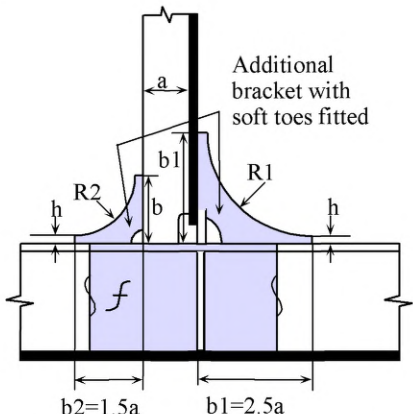
BULK CARRIERS		Guidelines for Surveys, Assessment and Repair of Hull Structure
Part 1	Cargo hold region	Example No.
Area 5	Double bottom tank structure including hopper	7
Detail of damage	Fractures in longitudinal at floor/transverse web frame or bulkhead	
Sketch of damage

<p>f: Where required, the longitudinal to be cropped and part renewed</p> <ol style="list-style-type: none"> 1. For a slope at toes max. 1:3, $R1=(b1-h) \times 1.6$ and $R2=(b2-h) \times 1.6$ 2. Soft toe bracket to be welded first to longitudinal 3. Scallop in bracket to be as small as possible, recommended max. 35mm 4. If toes of brackets are ground smooth, full penetration welds in way to be provided 5. Maximum length to thickness ratio = 50:1 for unstiffened bracket edge 6. Toe height, h, to be as small as possible (10-15mm)
Notes on possible cause of damage <ol style="list-style-type: none"> 1. Damage can be caused by stress concentrations leading to accelerated fatigue in this region. 		Notes on repairs <ol style="list-style-type: none"> 1. If fractures are not extensive e.g. hairline fractures, they can be veed-out and welded. 2. If fracture extends to over one third of the depth of the longitudinal then crop and part renew.

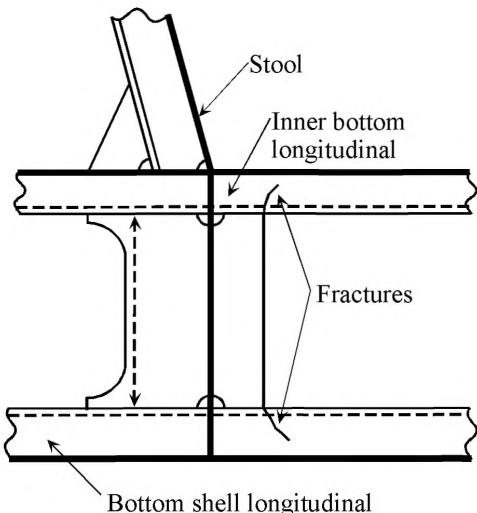
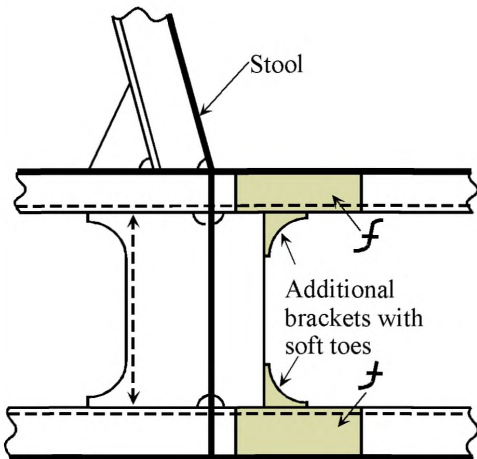
BULK CARRIERS		Guidelines for Surveys, Assessment and Repair of Hull Structure
Part 1	Cargo hold region	Example No.
Area 5	Double bottom tank structure including hopper	8
Detail of damage	Fractures in bottom and inner bottom longitudinals in way of inner bottom and bulkhead stool boundaries	
Sketch of damage		Sketch of repair

<p>f : Where required the longitudinal to be cropped and part renewed</p>
Notes on possible cause of damage		Notes on repairs
<ol style="list-style-type: none"> 1. Damage can be caused by stress concentration leading to accelerated fatigue in this region. 		<ol style="list-style-type: none"> 1. If fractures are not extensive e.g. hairline fractures then these can be vee-out and welded. 2. If fracture extended to over one third of the depth of the longitudinal then crop and part renew.

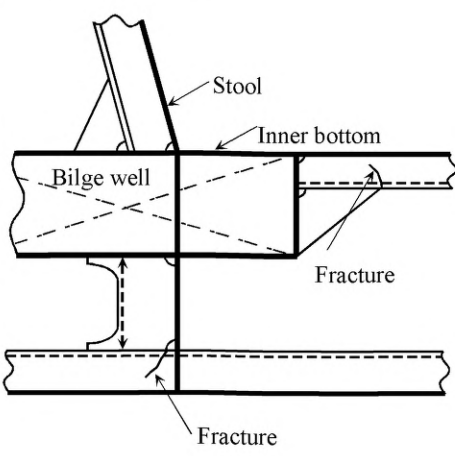
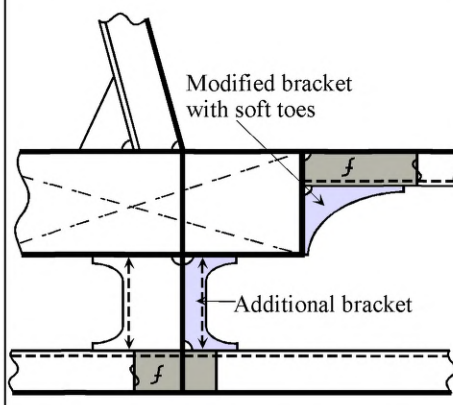
BULK CARRIERS		Guidelines for Surveys, Assessment and Repair of Hull Structure
Part 1	Cargo hold region	Example No.
Area 5	Double bottom tank structure including hopper	9
Detail of damage	Fractures in longitudinal in way of bilge well	
Sketch of damage		Sketch of repair

<p>f: Where required the longitudinals to be cropped and part renewed</p>
Notes on possible cause of damage		Notes on repairs
<ol style="list-style-type: none"> 1. Damage can be caused by stress concentrations leading to accelerated fatigue in this region. 		<ol style="list-style-type: none"> 1. If fractures are not extensive e.g. hairline fractures then these can be veed-out and welded. 2. If the fracture extended to over one third of the depth of the longitudinal then crop and part renew.

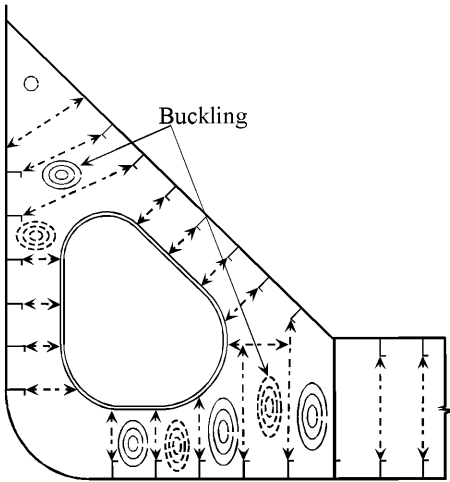
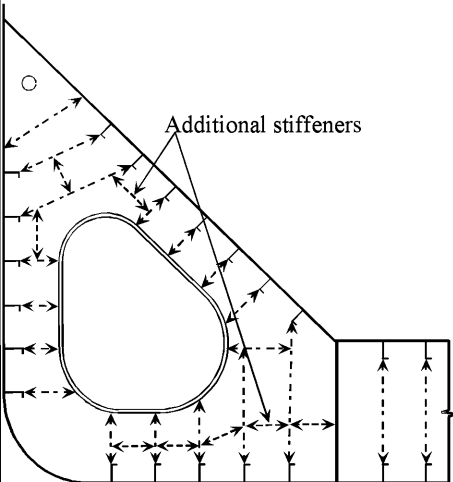
BULK CARRIERS		Guidelines for Surveys, Assessment and Repair of Hull Structure
Part 1	Cargo hold region	Example No.
Area 5	Double bottom tank structure including hopper	10
Detail of damage		Buckling of transverse web
Sketch of damage

Notes on possible cause of damage <ol style="list-style-type: none"> 1. Insufficient buckling strength of transverse web plating. 2. Corrosion of high stress area. 		Notes on repairs <ol style="list-style-type: none"> 1. If the buckling occurred without significant corrosion, adequate reinforcement is to be carried out. 2. If the buckling occurred due to corrosion of high stress (shear stress) area, damaged area is to be cropped and part renewed. Adequate reinforcement and protective measures should be considered.

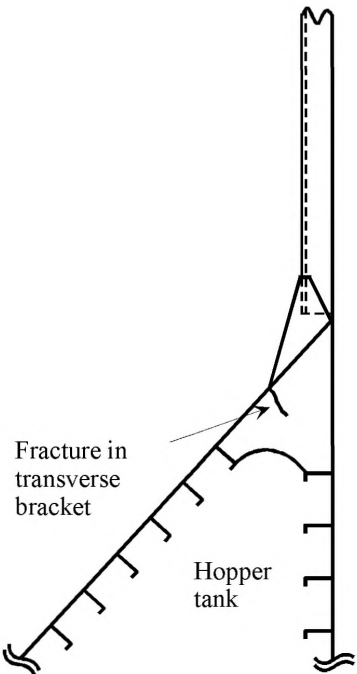
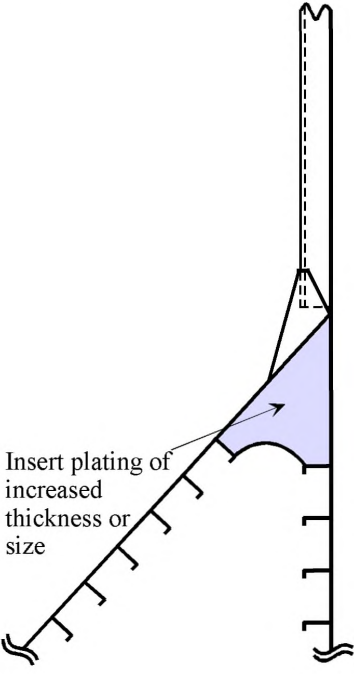
BULK CARRIERS		Guidelines for Surveys, Assessment and Repair of Hull Structure
Part 1	Cargo hold region	Example No.
Area 5	Double bottom tank structure including hopper	11
Detail of damage Fractures at weld connection of transverse brackets		
Sketch of damage		Sketch of repair

Notes on possible cause of damage		Notes on repairs
<ol style="list-style-type: none"> 1. General levels of corrosion and presence of stress concentration. 2. Misalignment of the brackets with adjoining structure e.g. frame brackets. 3. High shear stresses due to insufficient bracket. 4. Inadvertent overloading. 		<ol style="list-style-type: none"> 1. If the damage is caused by misalignment with the frame bracket above, the misalignment is to be rectified. 2. Replacement by a bracket of increased thickness or size should be considered.

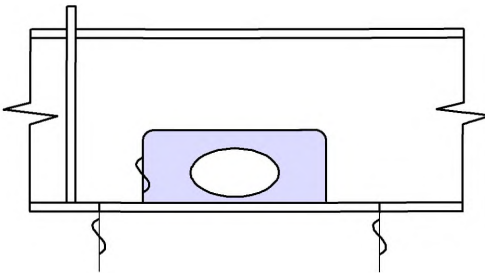
BULK CARRIERS		Guidelines for Surveys, Assessment and Repair of Hull Structure
Part 1	Cargo hold region	Example No.
Area 5	Double bottom tank structure including hopper	12
Detail of damage		Fractures in bottom shell/side shell/hopper sloping plating at the corner drain hole/air hole in longitudinal
Sketch of damage		Sketch of repair

Notes on possible cause of damage		Notes on repairs
<ol style="list-style-type: none"> 1. Stress concentration and/or corrosion due to stress concentration at the corner of drain hole/air hole. 		<ol style="list-style-type: none"> 1. Fractured plating should be cropped and part renewed. 2. If fatigue life is to be improved, change of drain hole/air hole shape is to be considered.

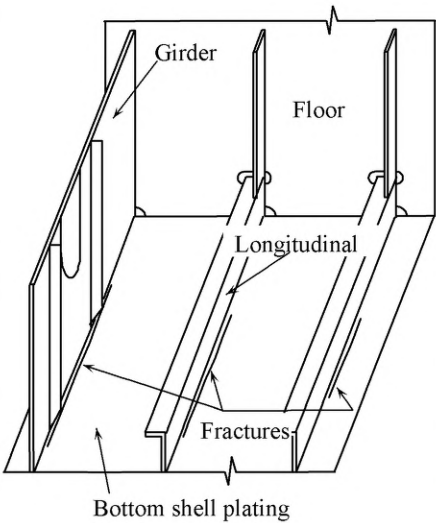
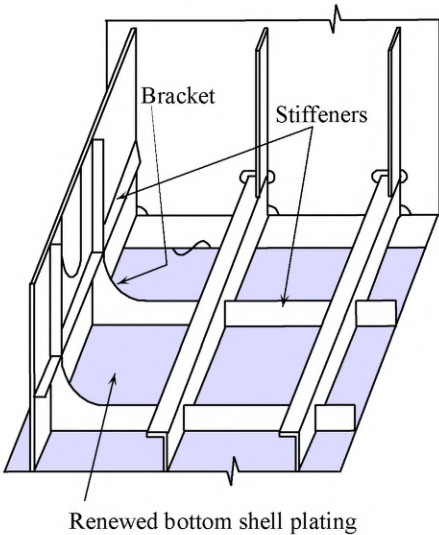
BULK CARRIERS		Guidelines for Surveys, Assessment and Repair of Hull Structure
Part 1	Cargo hold region	Example No.
Area 5	Double bottom tank structure including hopper	13
Detail of damage	Fractures in bottom plating along side girder and/or bottom longitudinal	
Sketch of damage

Notes on possible cause of damage 1. Vibration.		Notes on repairs 1. Fractured bottom shell plating should be cropped and renewed. 2. Natural frequency of the panel should be changed, e.g. reinforcement by additional stiffener/bracket.

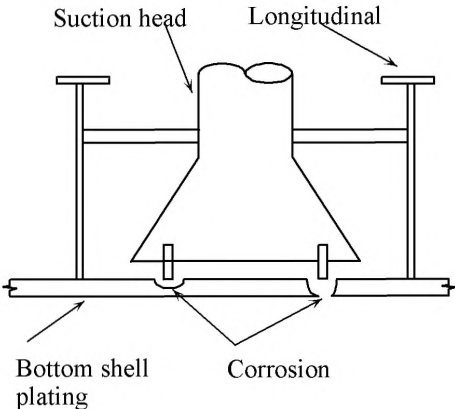
BULK CARRIERS		Guidelines for Surveys, Assessment and Repair of Hull Structure
Part 1	Cargo hold region	Example No.
Area 5	Double bottom tank structure including hopper	14
Detail of damage		Corrosion in bottom plating below suction head
Sketch of damage

5.1.2 Plating below suction heads and sounding pipes is to be replaced if the average thickness is below the acceptable limit (See **Examples 14 and 15**). When scattered deep pitting is found, it may be repaired by welding.

<p>1. Insert to have round corners 2. Non-destructive examination to be applied after welding based on the Society's rules</p>
Notes on possible cause of damage <ol style="list-style-type: none"> 1. High flow rate associated with insufficient corrosion prevention system. 2. Galvanic action between dissimilar metals. 		Notes on repairs <ol style="list-style-type: none"> 1. Affected plating should be cropped and part renewed. Thicker plate and suitable beveling should be considered. 2. If the corrosion is limited to a small area, i. e. pitting corrosion, repair by welding is acceptable.

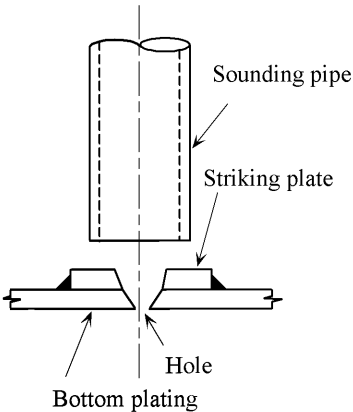
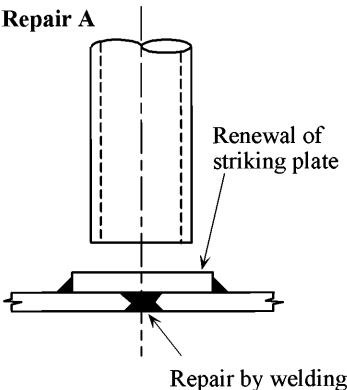
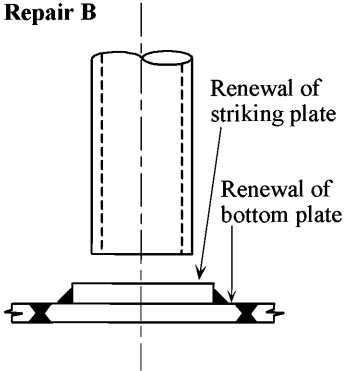
BULK CARRIERS		Guidelines for Surveys, Assessment and Repair of Hull Structure
Part 1	Cargo hold region	Example No.
Area 5	Double bottom tank structure including hopper	15
Detail of damage Corrosion in bottom plating below sounding pipe		
Sketch of damage

</div>
Notes on possible cause of damage <ol style="list-style-type: none"> 1. Accelerated corrosion of striking plate by the striking of the weight of the sounding tape. 		Notes on repairs <ol style="list-style-type: none"> 1. Corroded bottom plating should be welded or partly cropped and renewed if considered necessary. 2. Corroded striking plate should be renewed.

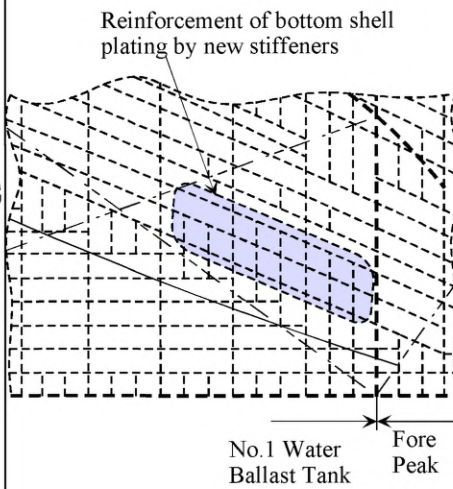
BULK CARRIERS		Guidelines for Surveys, Assessment and Repair of Hull Structure
Part 1	Cargo hold region	Example No.
Area 5	Double bottom structure including hopper	16
Detail of damage		Deformation of forward bottom shell plate due to slamming
Sketch of damage		Sketch of repair

Notes on possible cause of damage		Notes on repairs
<ol style="list-style-type: none"> Heavy weather. Poor design for slamming. Poor operation, i.e. negligence of heavy ballast. 		<ol style="list-style-type: none"> Deformed bottom shell plating should be faired in place, or partly cropped and renewed if considered necessary. Bottom shell plating should be reinforced by stiffeners.

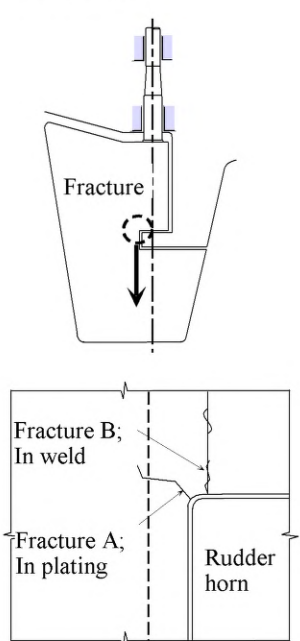
BULK CARRIERS		Guidelines for Surveys, Assessment and Repair of Hull Structure
Part 2	Fore and aft end regions	Example No.
Area 3	Stern frame, rudder arrangement and propeller shaft support	6
Detail of damage	Fractures in rudder plating of semi-spade rudder in way of pintle cutout	
Sketch of damage

Notes on possible cause of damage <ol style="list-style-type: none"> 1. Inadequate design for stress concentration in way of pintle bearing (Fracture A). 2. Imperfection in welding seam (Fracture B). 		Notes on repairs <ol style="list-style-type: none"> 1. Fractured part to be cropped off. 2. Repair by two insert plates of modified, stress releasing contour. For the vertical seam no backing strip is used 100mm off contour, welding from both sides, to be ground after welding. 3. Variant (See Detail A): Repair as mentioned under 2 with the use of backing strip for the complete vertical seam. After welding backing strip partly removed by grinding.

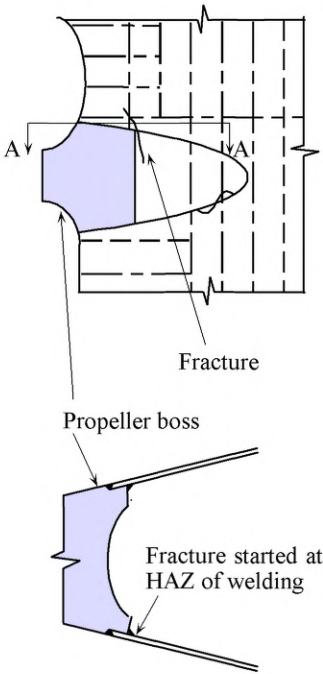
BULK CARRIERS		Guidelines for Surveys, Assessment and Repair of Hull Structure
Part 2	Fore and aft end regions	Example No.
Area 3	Stern frame, rudder arrangement and propeller shaft support	7
Detail of damage		Fractures in side shell plating at the connection to propeller boss
Sketch of damage

<p>Fracture</p> <p>Propeller boss</p> <p>Fracture started at HAZ of welding</p> <p>View A - A</p>		Sketch of repair

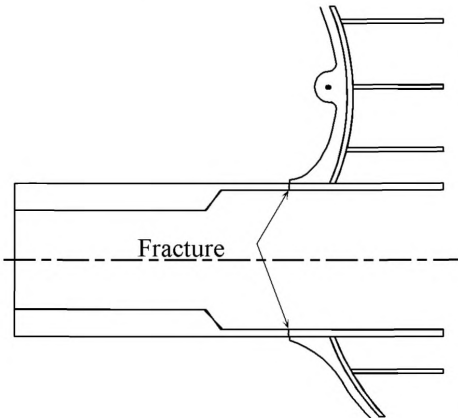
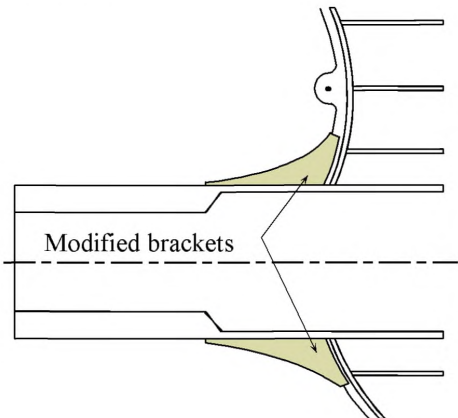
BULK CARRIERS		Guidelines for Surveys, Assessment and Repair of Hull Structure
Part 2	Fore and aft end regions	Example No.
Area 3	Stern frame, rudder arrangement and propeller shaft support	8
Detail of damage		Fractures in stern tube at the connection to stern frame
Sketch of damage		Sketch of repair

Notes on possible cause of damage		Notes on repairs
<ol style="list-style-type: none"> 1. Fatigue fracture due to vibration. 		<ol style="list-style-type: none"> 1. Fractured tube is to be veed-out and welded from both sides. 2. Brackets are to be replaced by modified brackets with soft transition.
